# **Opendoor** INSPECTION REPORT FINDINGS A ND FIXES 418 W Santa Maria St, Tucson, AZ

**85706** Chris Mackenzie September 26, 2022

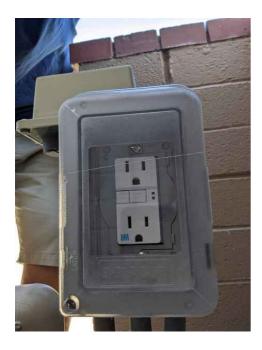
12.12.1 Pool electrical UNABLE TO LOCATE A GFCI What Opendoor did

## What the independent inspector noted: Opendoor standards issue

Unable to locate a GFCI protected circuit for the pool light. Recommend consulting the sellers for the locations and/or have a pool specialist evaluate and correct as needed.

A professional located the GFCI protected circuit for the pool light.
