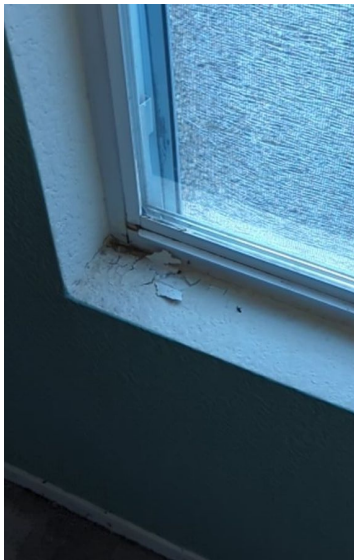
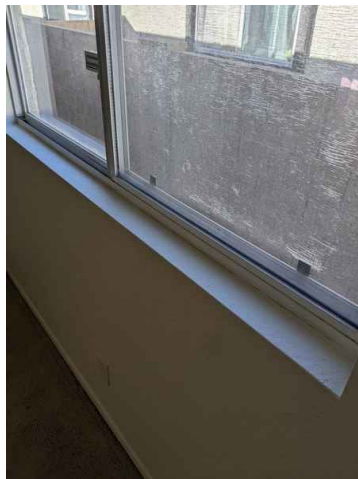
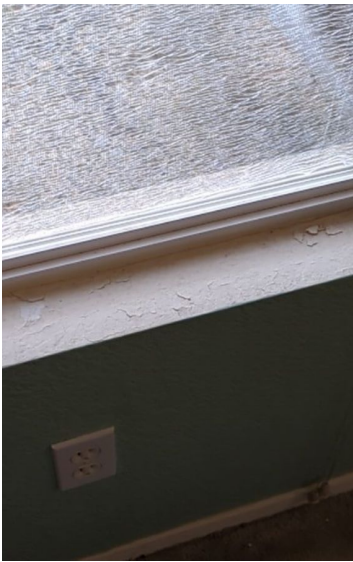
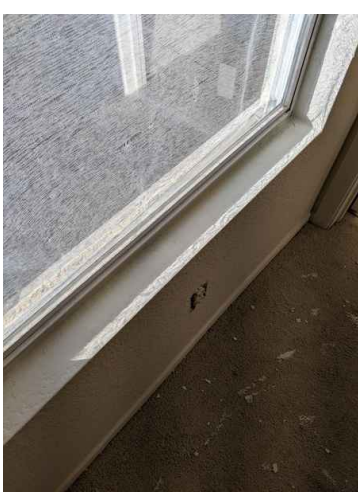
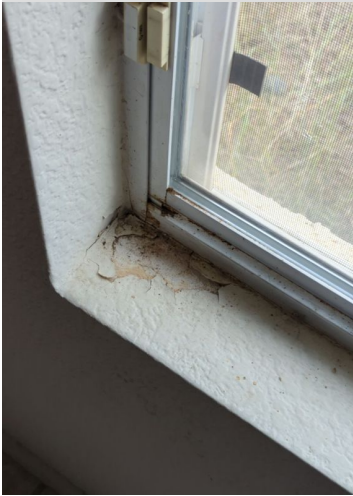
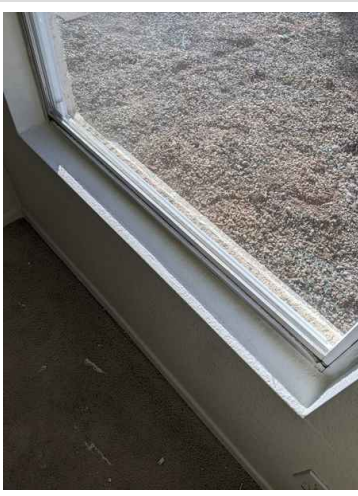
There is some typical damage in the drywall. This does not impact the livability of the home and can be repaired at your discretion.

A professional cleaned and repaired the window sills prior to repainting.

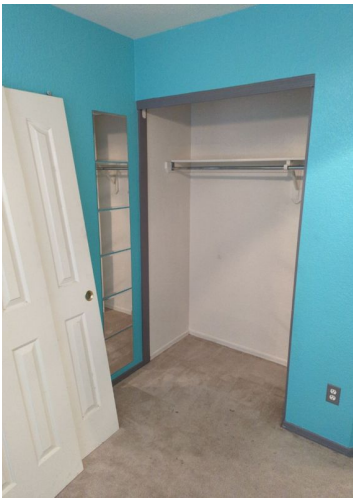
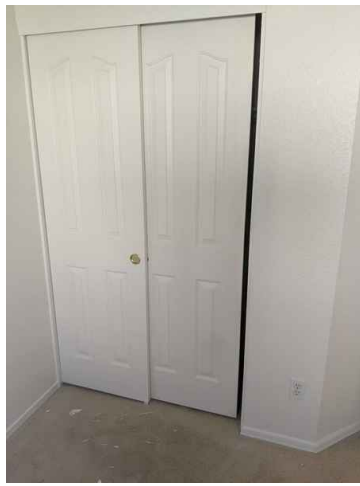
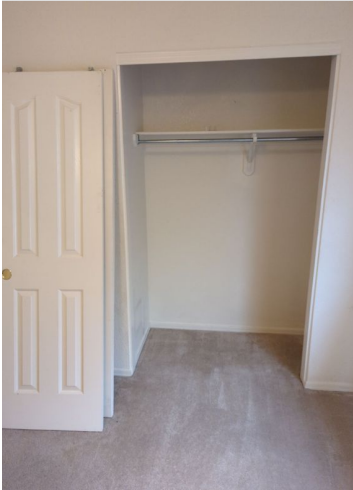
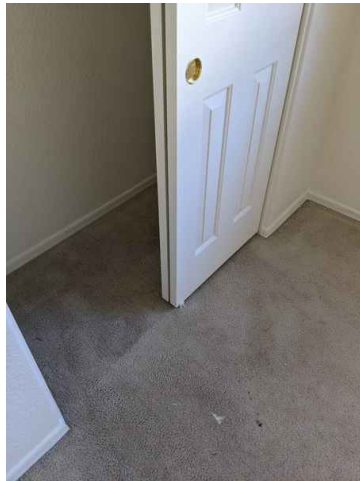
The door is not installed.

A professional installed the sliding bedroom closet doors that were not installed.

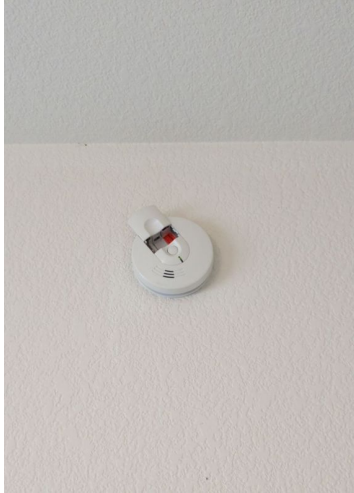
Original Photo
Bedroom 2

There are not smoke alarms found in all the current recommended areas or the alarms are inoperable in some locations. Recommend adding additional smoke alarms per the current standards.

A professional replaced all the aged or weak sounding smoke detectors in this home.

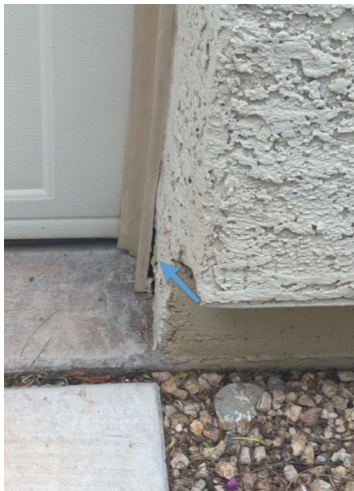
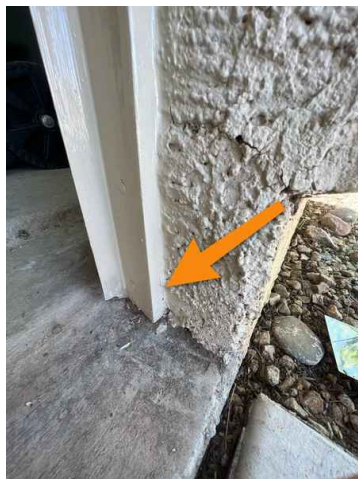
Original Photo

The garage door weatherstripping or trim is missing or damaged. Recommend repair or replacement.

A professional repaired the damaged trim along the garage door.

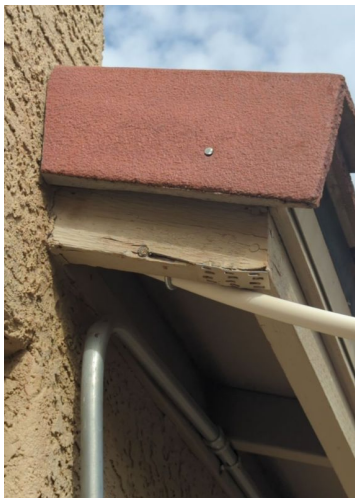
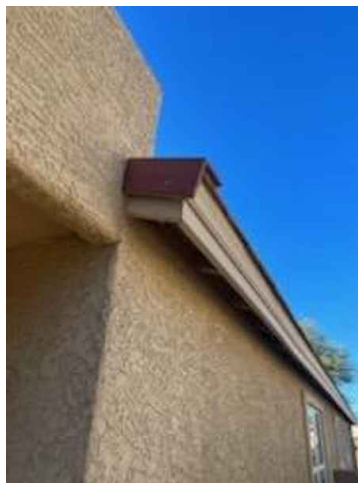
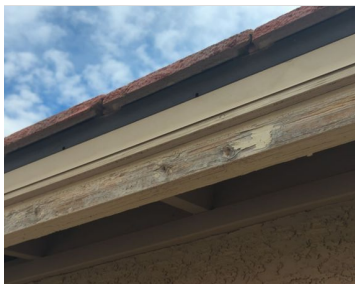
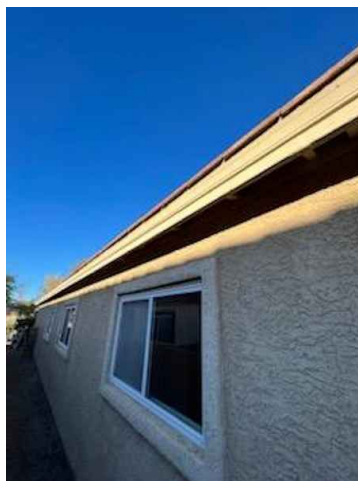
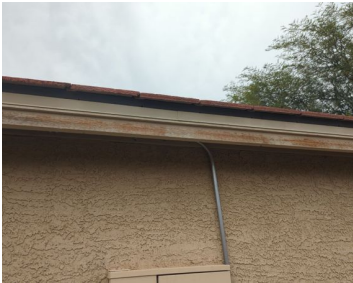
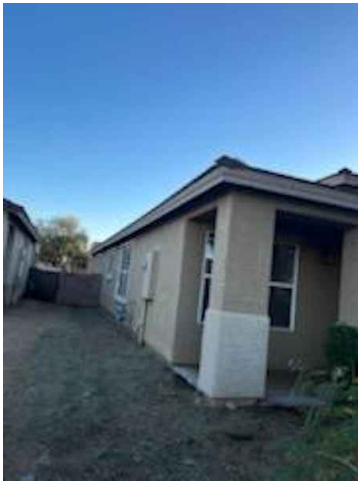
The fascia, eaves, and soffit are in need of typical maintenance. Observations include peeling paint and separation of attachment hardware.

Apologies for the poor quality after-photos, but a professional cleaned, sanded, caulked and painted the fascia where the inspector noted to help seal it.

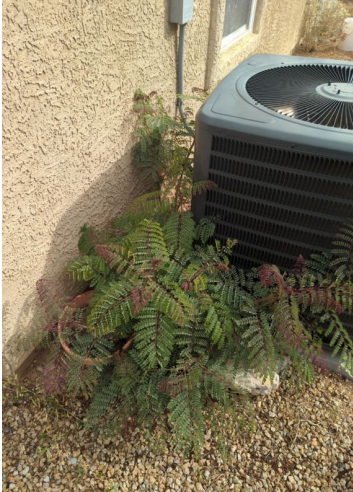
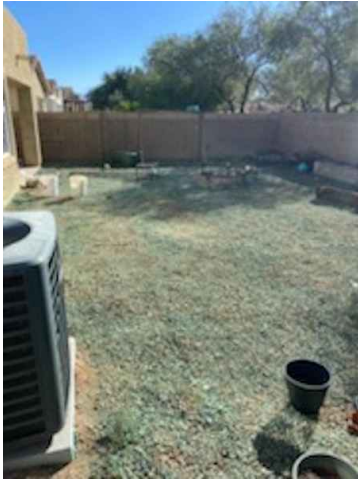
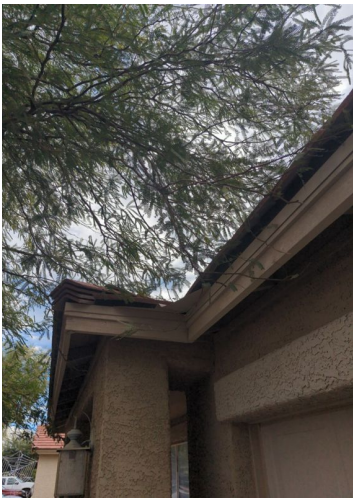
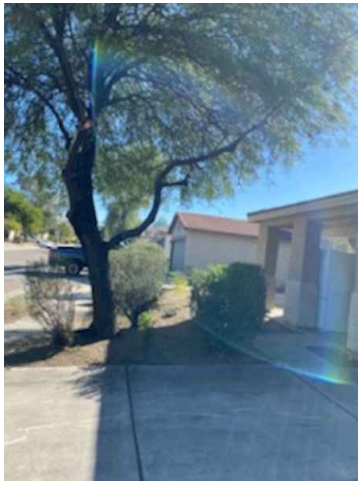
There is vegetation that is overhanging the roof or against the siding. Vegetation can damage the siding and/or roofing material and create an easy way for pests to enter the home. Recommend trimming the vegetation that is in contact or proximity to home.

A professional trimmed back the plants that grew too near the home or overhung the roof.

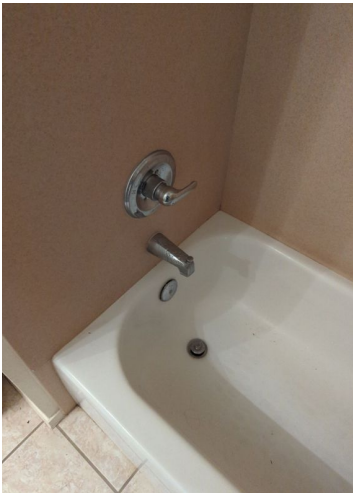
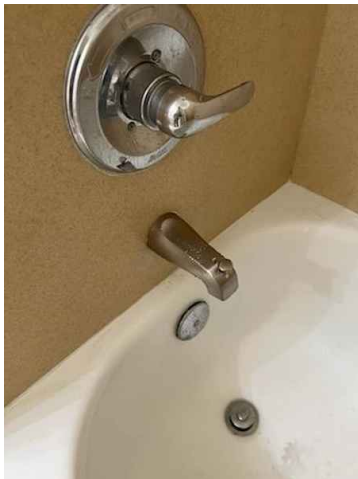
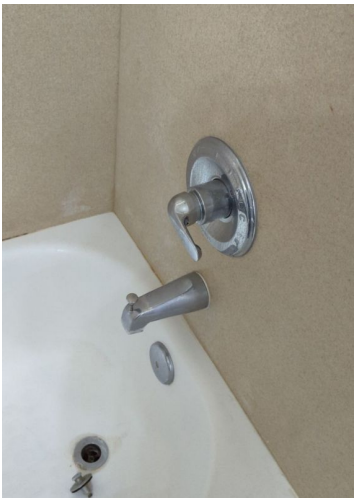
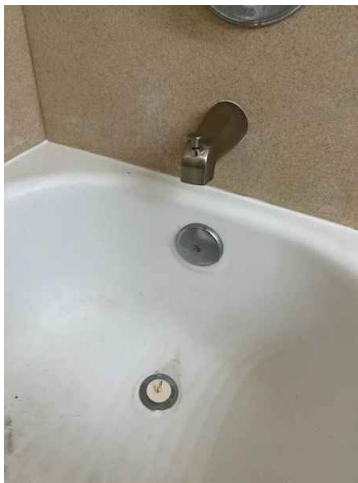
The shower diverter is not properly transferring water between the water fixtures in the shower/tub. This will result in a loss of water flow to the shower head. Recommend repair.

A professional fixed the diverters in both bathtubs and tested to make sure they're working properly.

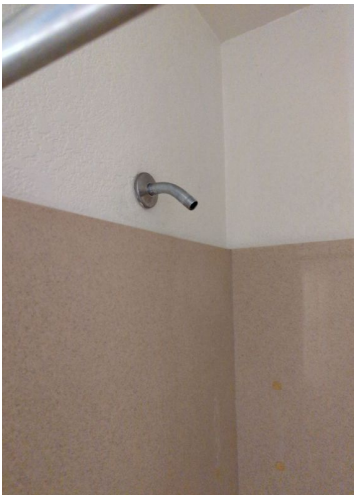
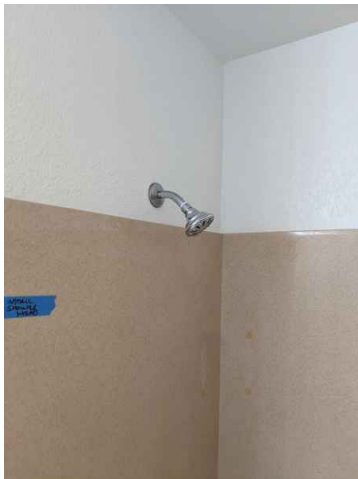
Original Photo
Bathroom 2

The shower head is damaged. Recommend replace.

A professional replaced the missing shower head.

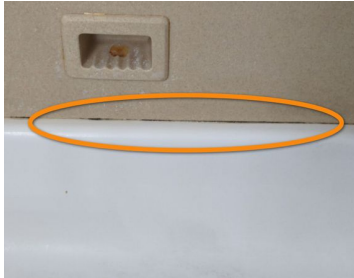
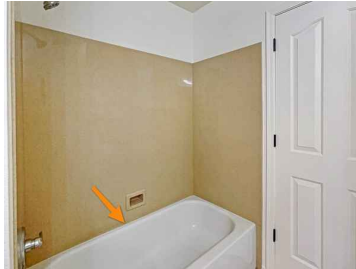
Original Photo
Primary Bathroom

There are open joints observed in the shower walls or base. Recommend repairing with caulk or grout to help prevent water penetration to the underlying materials. Unable to determine condition of underlying materials.

A professional applied a fresh bead of caulking to the primary bathroom's tub to help seal it.

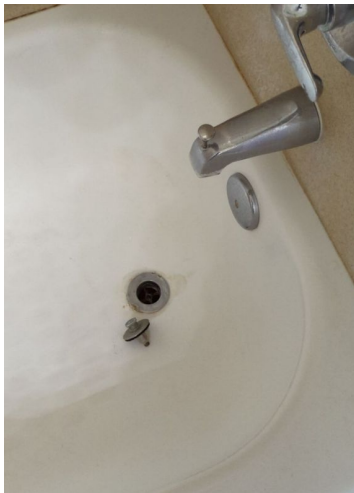
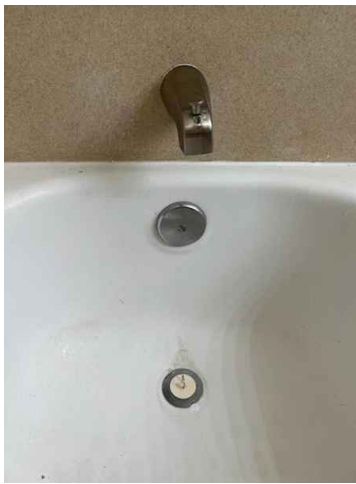
Original Photo
Primary Bathroom

The drain stopper is inoperable or does not seal properly.

We provided this tub with a universal rubber stopper as an temporary solution. The next owner may want to hire a qualified plumbed to repair or replace the stopper mechanism.

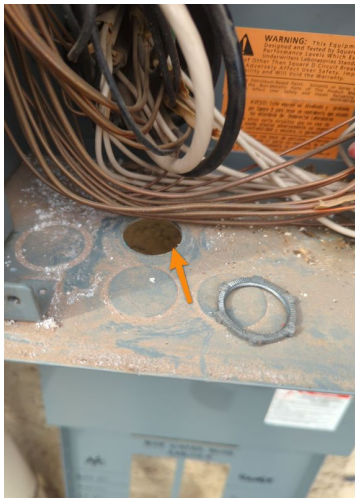
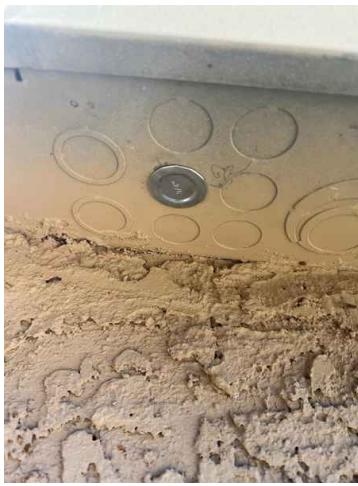
Original Photo
Panel

There are missing knockouts in the main or sub electrical panel. Recommend repair.

A professional installed covers where the knockouts were missing.

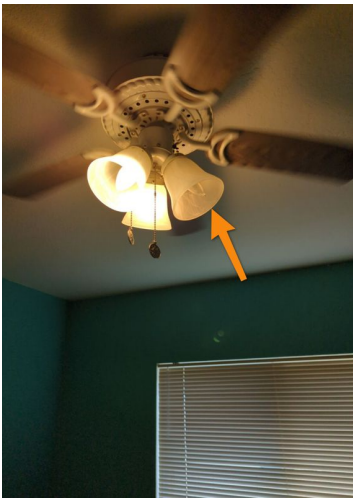
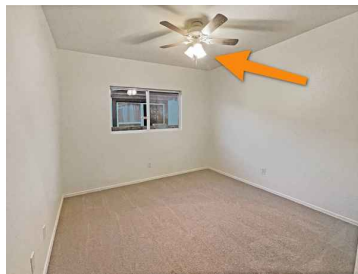
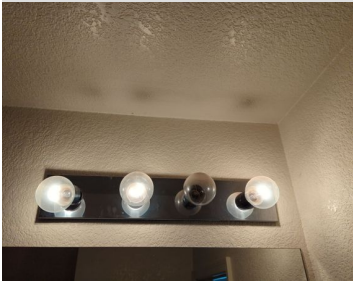
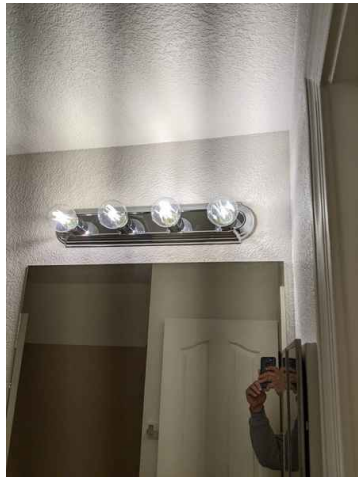
There is a light fixture or bulb that is inoperable. Replace the bulb and test or repair as needed.

A professional replaced all burned-out light bulbs in the fixtures and ceiling fans.

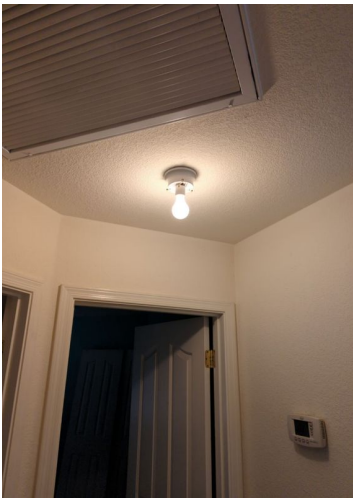
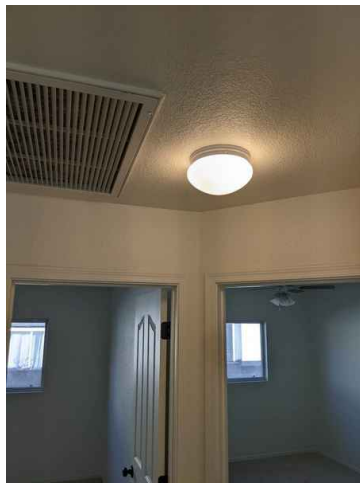
Original Photo
Hallway

There is a light fixture missing the cover. Recommend repair.

A professional replaced the light fixture in the hallway, but left the bare bulb fixture in the garage as it's height and placement make it less likely to be bumped or damaged.

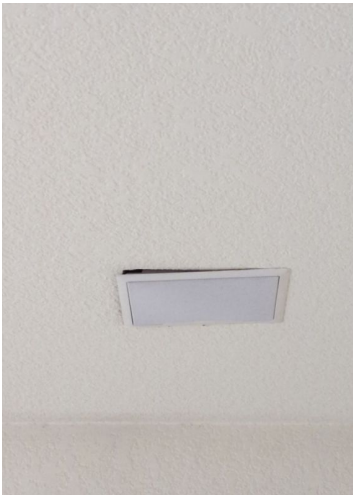
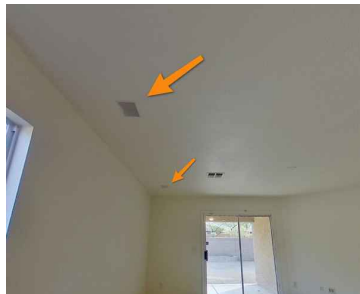
Original Photo
Living Room

The speaker is falling out of the ceiling. Recommend repair.

A professional secured the in-ceiling speaker to the ceiling in the living room where a gap had formed.

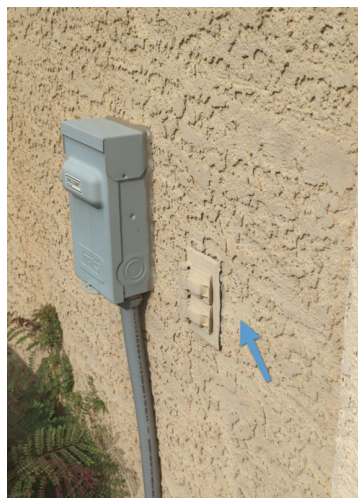
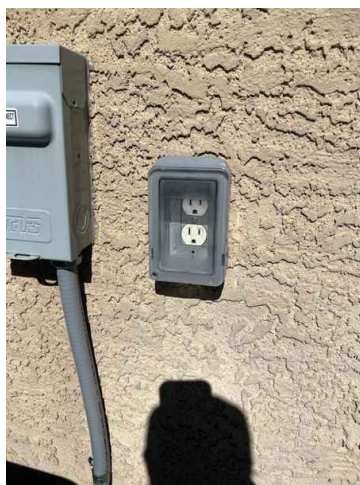
Original Photo
Back Side of the house

The exterior outlet is not protected from the elements. The inspector recommends replacement with a weather rated cover that covers the outlet, even when it is in use.

A professional installed this outlet in a new, weather rated box for safety.

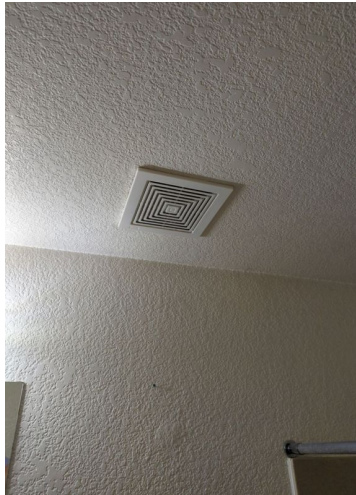
Original Photo
Primary Bathroom

The bath fan is inoperable. Recommend replacing in order to provide proper ventilation.

A professional replaced the broken ventilation fan in this bathroom.
