1.1.1 Property Notes and Limitations

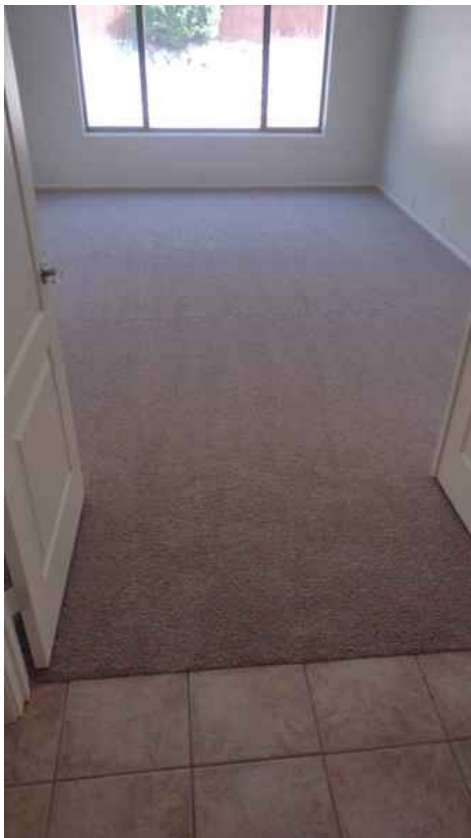
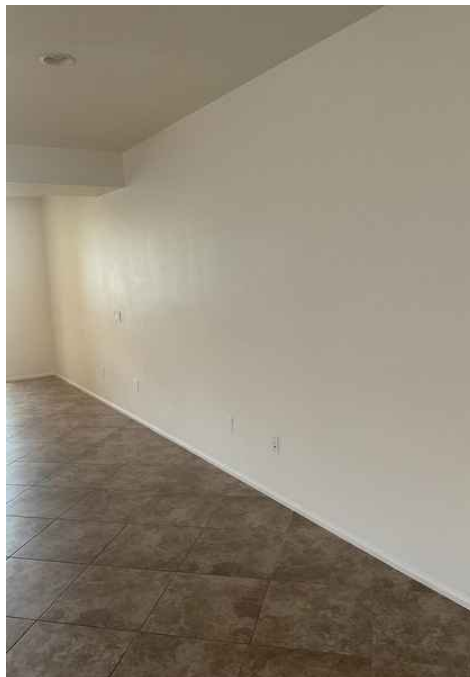
PET ODOR/STAINING

ALL LOCATIONS

What the independent inspector noted: There is excessive pet odor and staining observed on the property. This may require professional cleaning and/or replacement of materials to eliminate the odor. Recommend further evaluation and repair as needed.

A professional removed and replaced the carpet and pad in the rooms with new, and repainted the interior of the home.

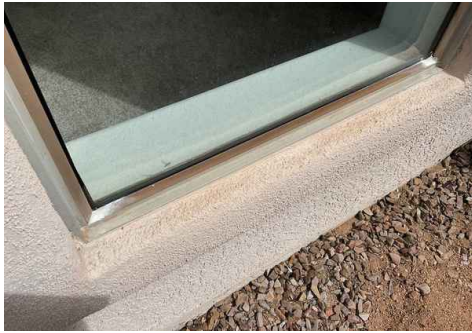
FAILED WINDOW SEALS - RUBBER GASKET

SIDE OF THE HOUSE

What the independent inspector noted: The rubber gasket of the window seal is failed or sagging. Recommend further evaluation of all windows and repair or replace as needed.

A professional repaired the rubber gasket around this window.
