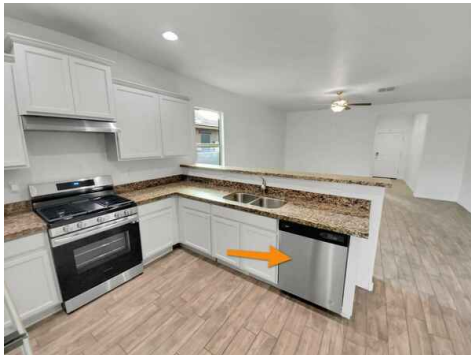
2.2.1 Dishwasher

DISHWASHER NOT TESTED - WATER SERVICE OFF

The water service and/or electrical service is off at time of the inspection. Unable to determine the condition of the system and/or the function of plumbing fixtures. The unit has not been tested.

A professional confirmed the dishwasher worked after restoring the water service.

Contact a qualified professional.

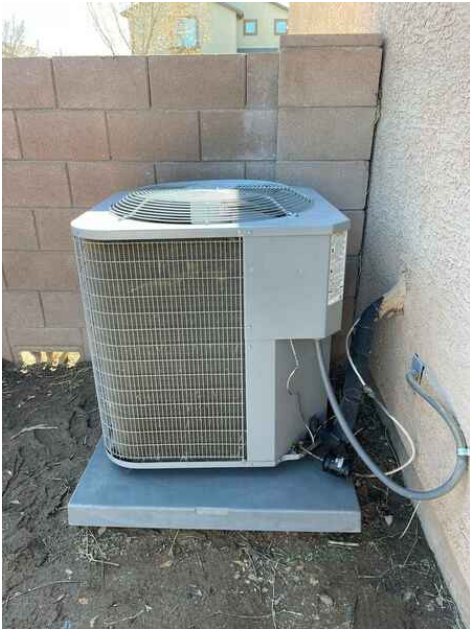
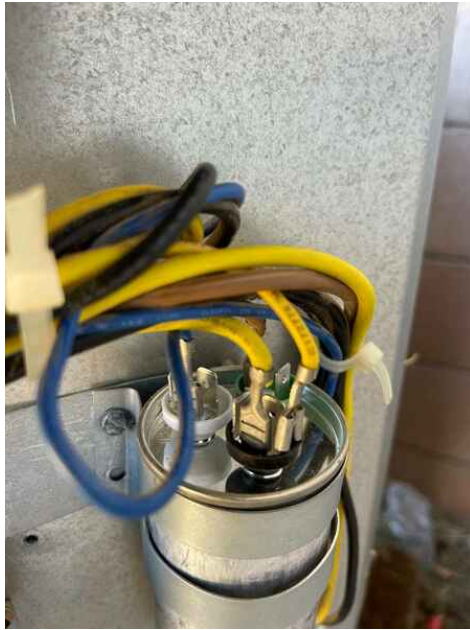
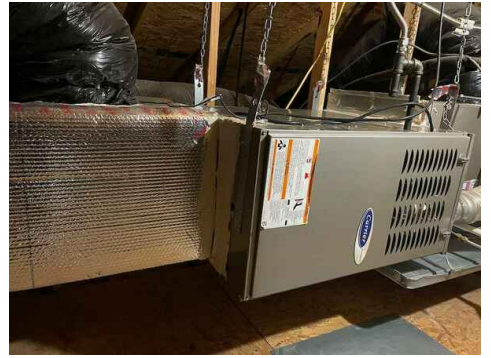
9.2.1 HVAC Inspection

NO VISIBLE SERVICE DATE - SERVICE RECOMMENDED

The last service date is over one year ago or is unable to be determined. The unit may be operating properly from controls but there are areas which cannot be seen without specialized equipment, removing covered areas, and/or invasive examination. Recommend consulting the owner for recent service or repair records and/or have an HVAC specialist service the unit.

A professional serviced the HVAC units on this home.

Contact a qualified professional.
