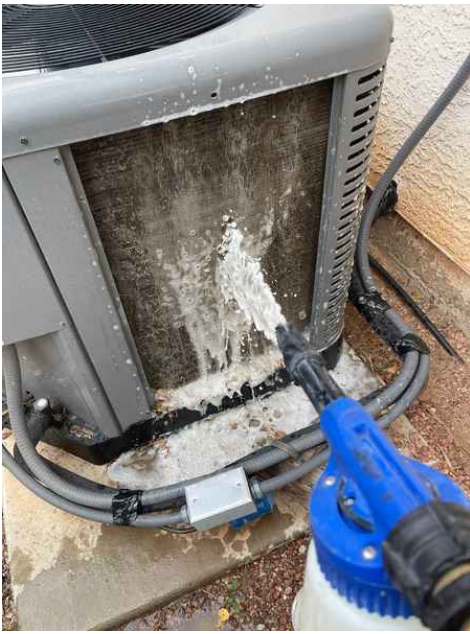
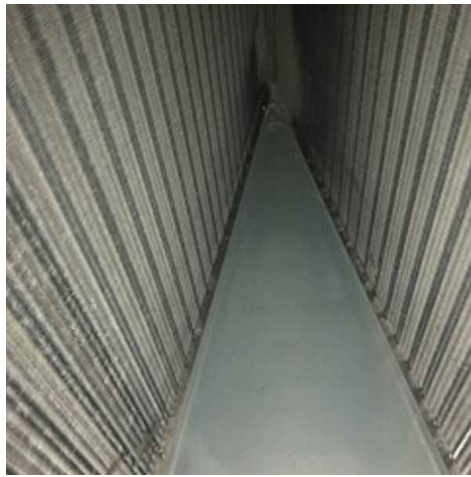
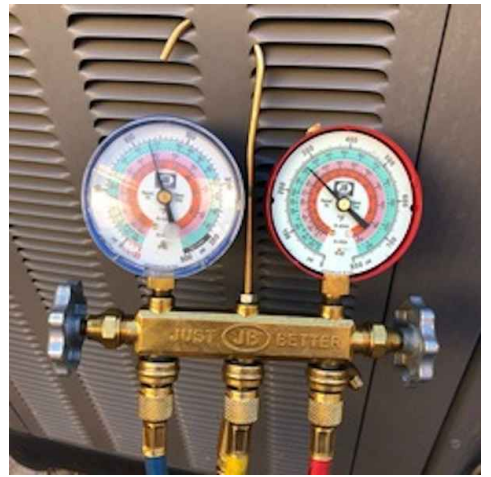
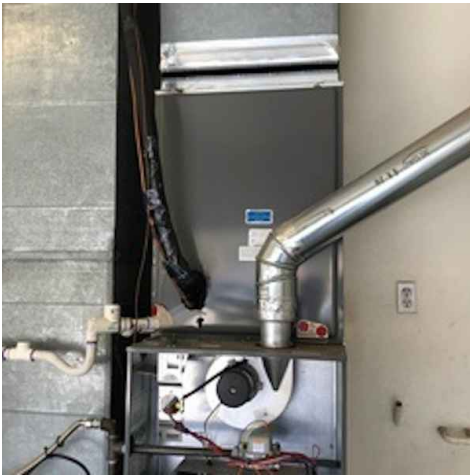
9.2.1 HVAC Inspection

NO VISIBLE SERVICE DATE - SERVICE RECOMMENDED

What the independent inspector noted:

The last service date is over one year ago or is unable to be determined. The unit may be operating properly from controls but there are areas which cannot be seen without specialized equipment, removing covered areas, and/or invasive examination. Recommend consulting the owner for recent service or repair records and/or have an HVAC specialist service the unit.

What Opendoor did

A professional performed a general service on the HVAC system including: cleaning condenser and evaporator coils, clearing condensate drain line with air/nitrogen, check temp splits, check refrigerant levels if temp splits are not within specs, check thermostat, check amp draws and confirm they are within manufacturer specifications - Overall condition of the unit should ensure proper temp splits.
