## 2.3.1 Oven Condition

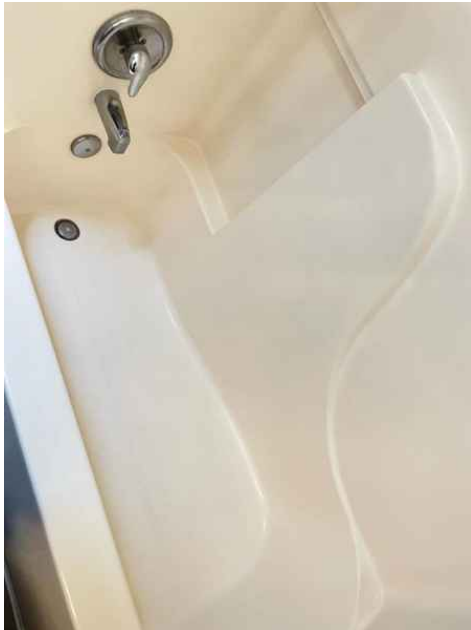
BATHROOM 2

### What the independent inspector noted:

The drain stopper is missing.

### What Opendoor did

A professional installed a new drain stopper.
