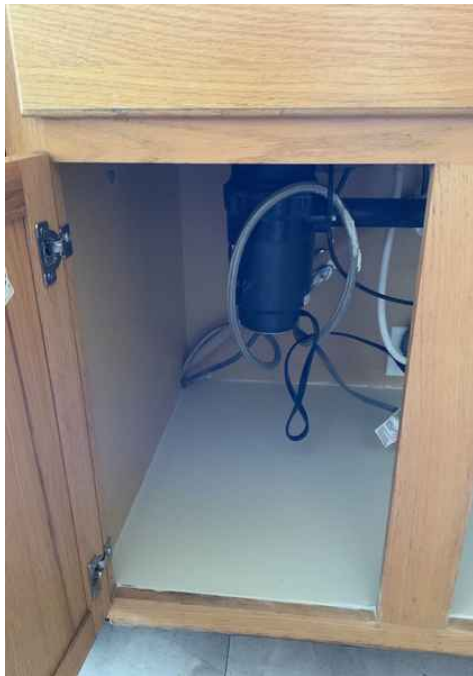
2.6.1 Garbage Disposal

INOPERABLE

The garbage disposal is inoperable or unresponsive to the controls at time of inspection. Recommend further review for repair or replacement.

A professional installed a new garbage disposal.
