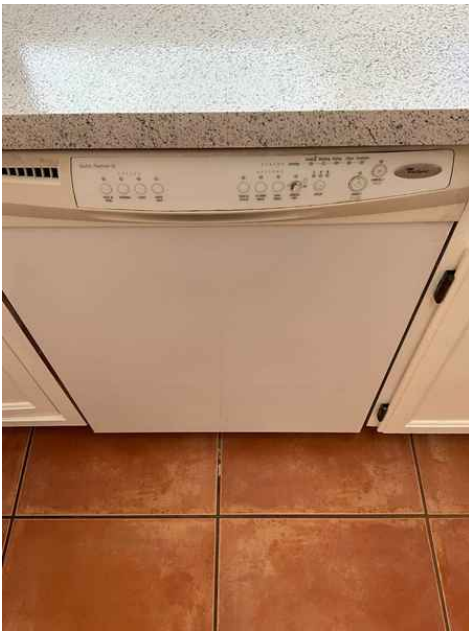
2.2.1 Dishwasher

DISHWASHER NOT TESTED - WATER SERVICE OFF

The water service is off at time of the inspection. Unable to determine the condition of the system and/or the function of plumbing fixtures. The unit has not been tested.

A professional checked the operation of this dishwasher by running a test cycle and it is working properly.

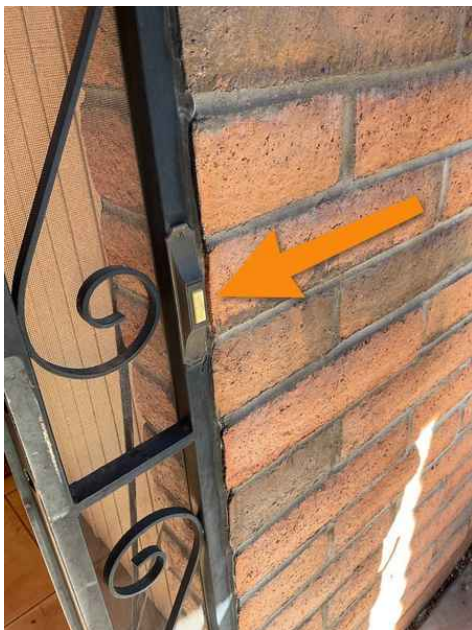
3.11.1 Door Bell

DOOR BELL NOT FUNCTIONAL

The door bell did not operate when tested (no power to home). Recommend repair.

A professional replaced the broken doorbell on this home.

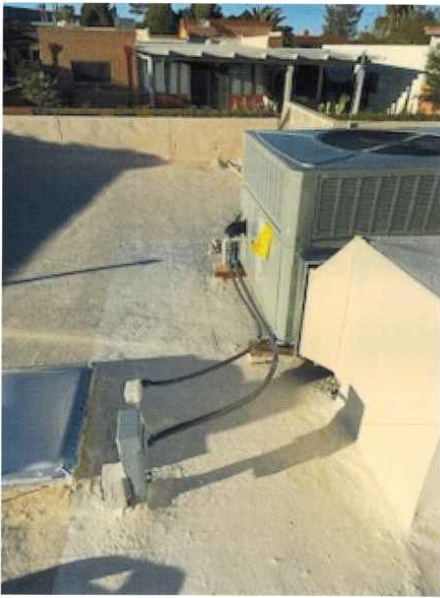
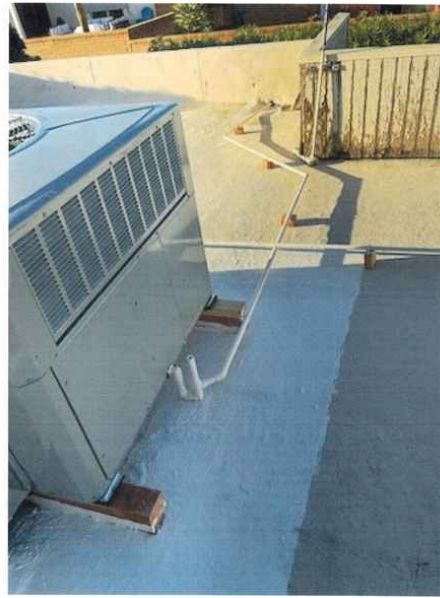
9.2.1 HVAC Inspection

NO VISIBLE SERVICE DATE - SERVICE RECOMMENDED

The last service date is over one year ago or is unable to be determined. The unit may be operating properly from controls but there are areas which cannot be seen without specialized equipment, removing covered areas, and/or invasive examination. Recommend consulting the owner for recent service or repair records and/or have an HVAC specialist service the unit.

A professional HVAC company installed a brand new AC system and furnace in this home, replacing an older R-22 unit from 1998. The next owner should have reliable and efficient cooling and heat for years to come!
