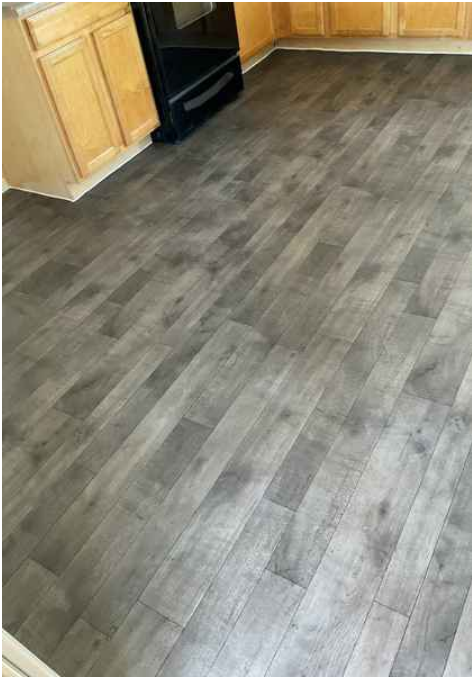
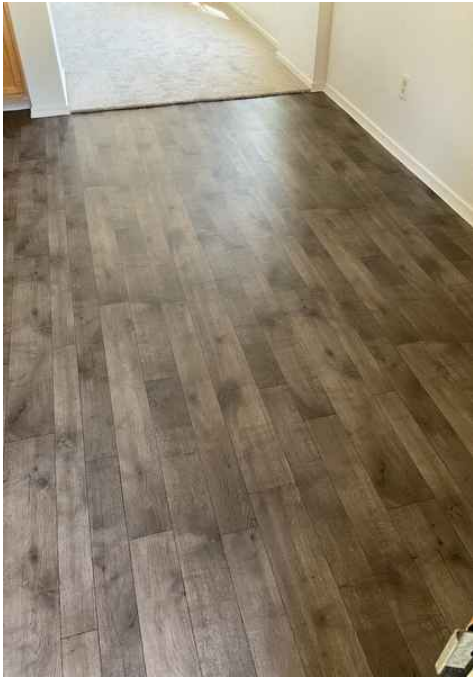
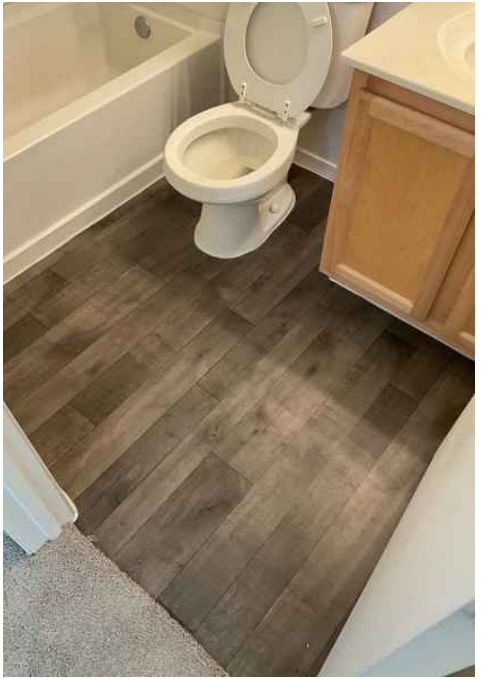
NEW VINYL FLOORING!

A professional crew installed attractive new vinyl flooring in multiple areas for a fresh look and water resistant durability.

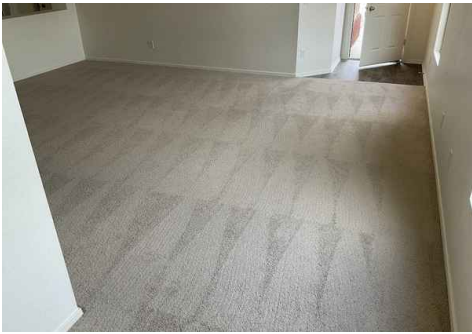
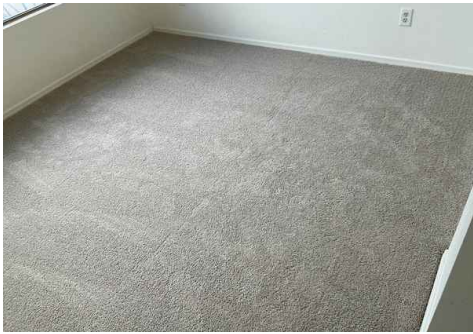
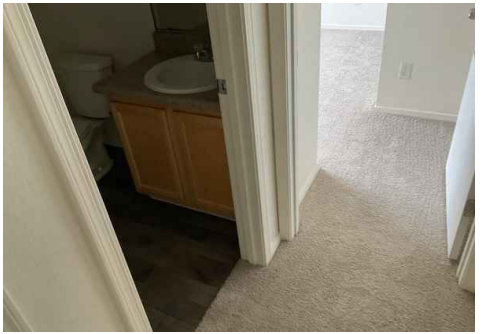
NEW CARPET!

A professional crew installed new carpet and pad throughout the house for a fresh feeling underfoot.
