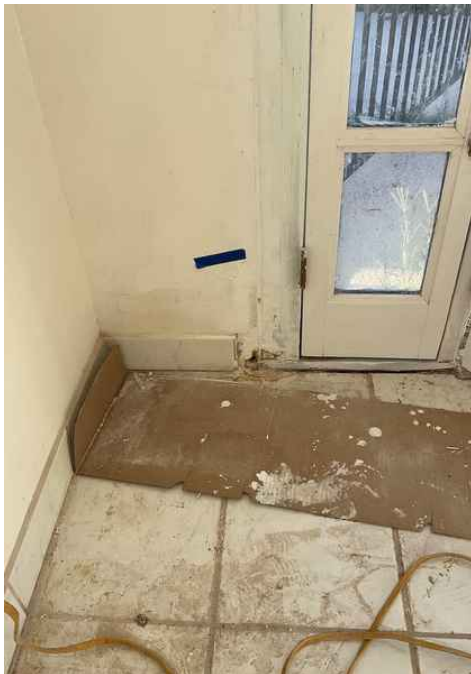
There are indications of moisture entering structure from the exterior. This is made evident by the stains and/or damage found on the floor. Recommend further review of the exterior systems and repair as directed.

in progress repairs

A professional made sure that there was no active water entering the home, replaced the sheetrock, trim and painted this area as part of the whole home interior paint job.
