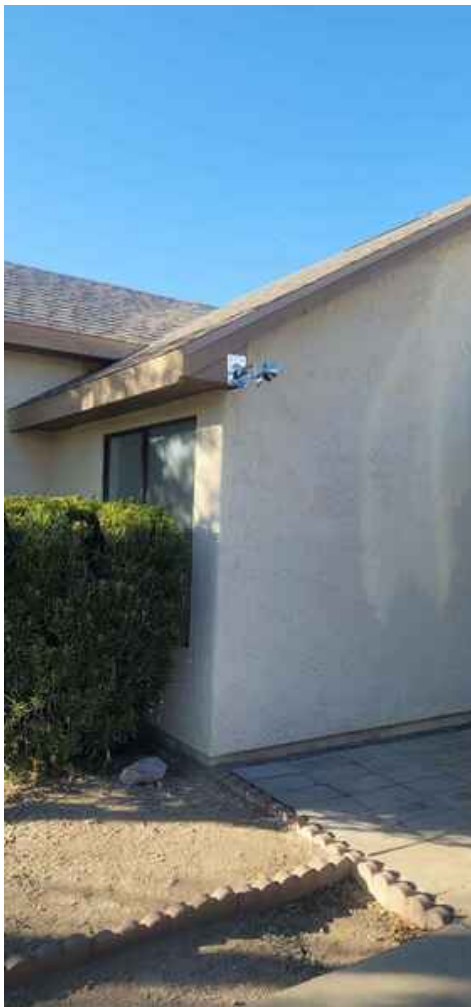
BIRDS

There are birds nesting, current activity, or preventative measures observed on the house. The presence of birds can damage the structure and speed the deterioration of the material. Recommend removing any active birds and ensuring that any preventative measures taken work to keep the birds away from the house.

A professional installed an anti-bird device to help prevent further nesting behavior at the home.

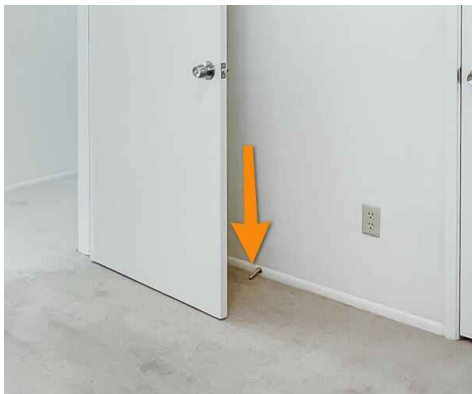
REPLACE/ADD DOOR STOPPERS

Replace or add missing door stoppers to prevent damage to the drywall.

A professional replaced any missing door stoppers and added them where needed to prevent accidental wall damage from door hardware.

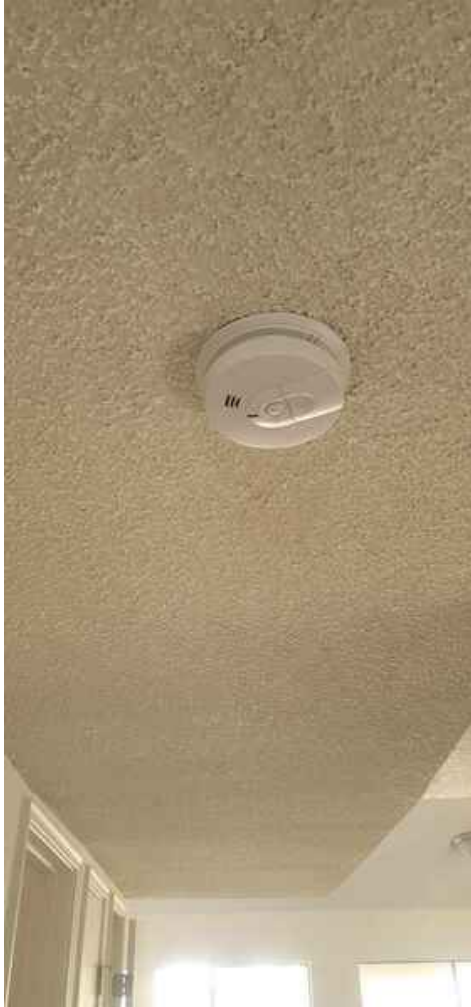
THE SMOKE ALARMS ARE AGED

This is indicated by yellowing or a weak signal. Recommend replacement.

A professional replaced all aged smoke detectors with new and installed fresh batteries throughout.

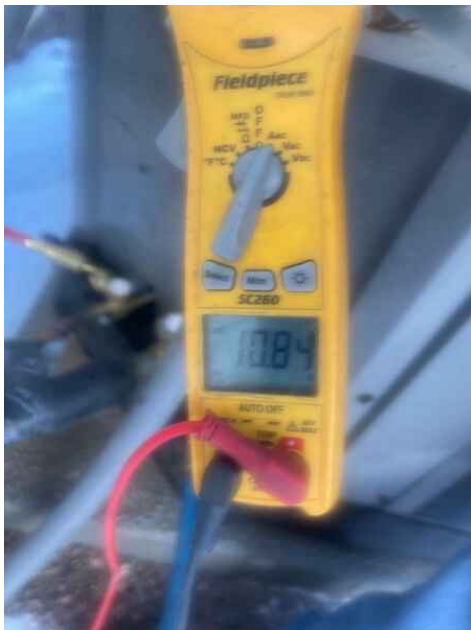
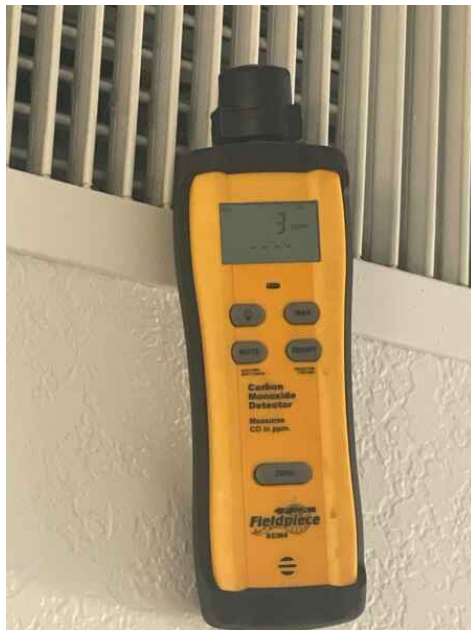
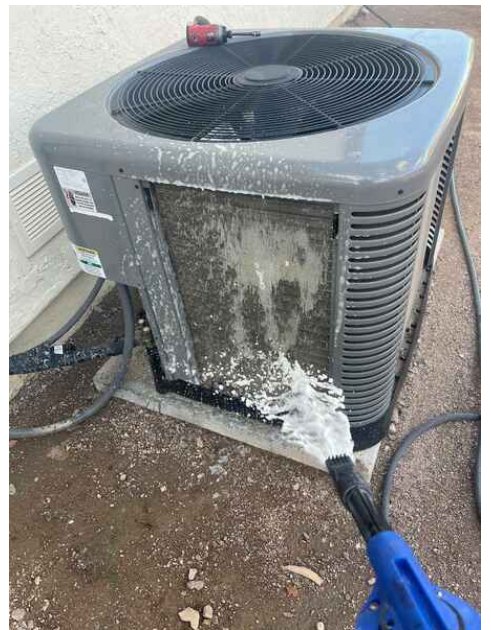
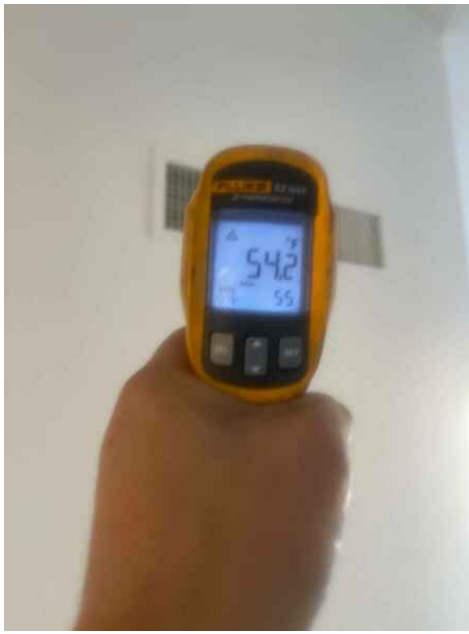
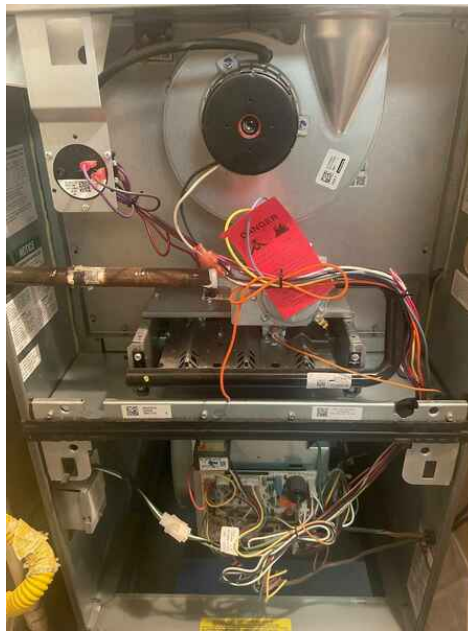
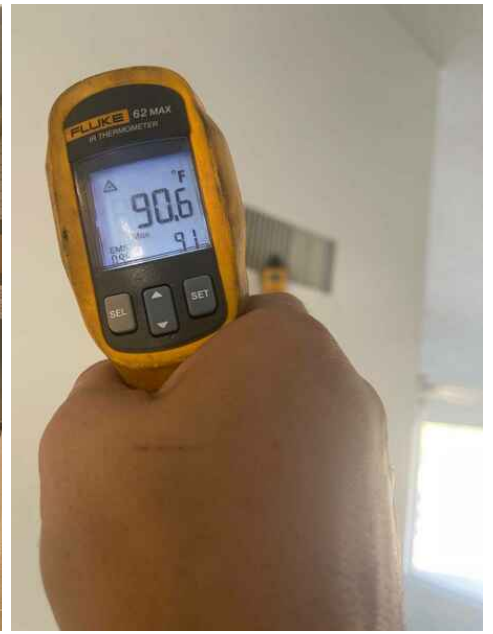
NO VISIBLE SERVICE DATE - SERVICE RECOMMENDED

The last service date is over one year ago or is unable to be determined. The unit may be operating properly from controls but there are areas which cannot be seen without specialized equipment, removing covered areas, and/or invasive examination. Recommend consulting the owner for recent service or repair records and/or have an HVAC specialist service the unit.

A professional HVAC company came out and did a complete test and servicing of this air conditioner and furnace and made sure it was in proper working condition for the next owner.
