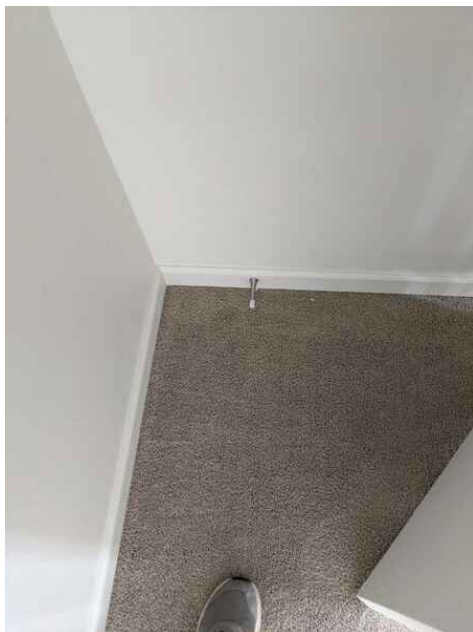
REPLACE/ADD DOOR STOPPERS

Replace or add missing door stoppers to prevent damage to the drywall.

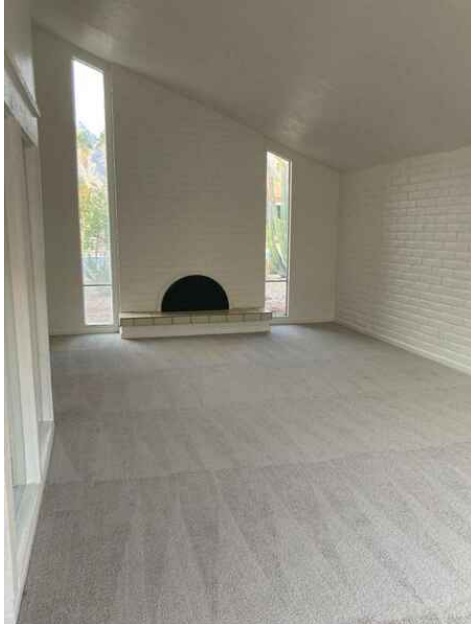
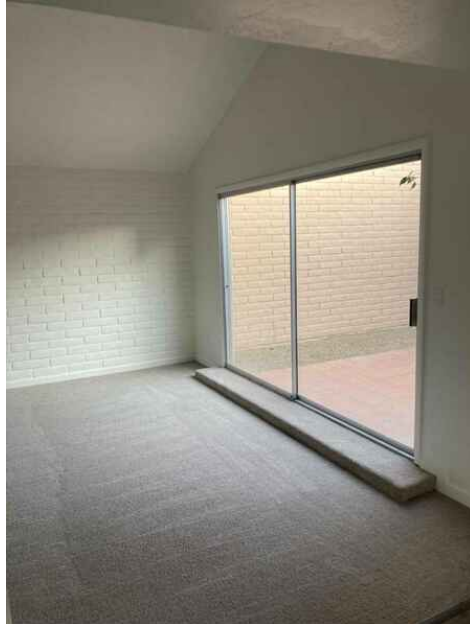
A professional crew removed all old, worn carpets, pad, and flooring and replaced with new carpet for a fresh feeling underfoot.

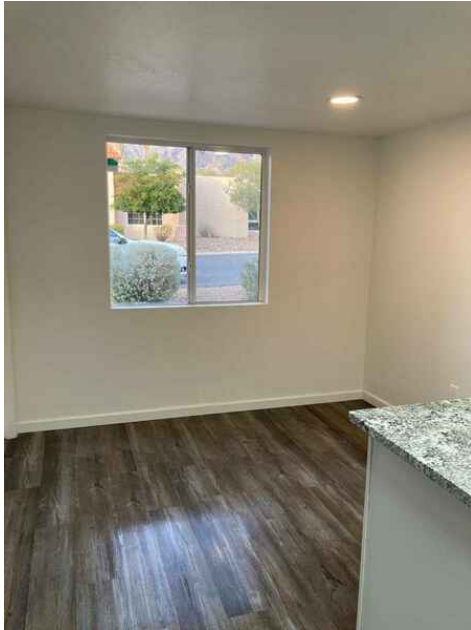
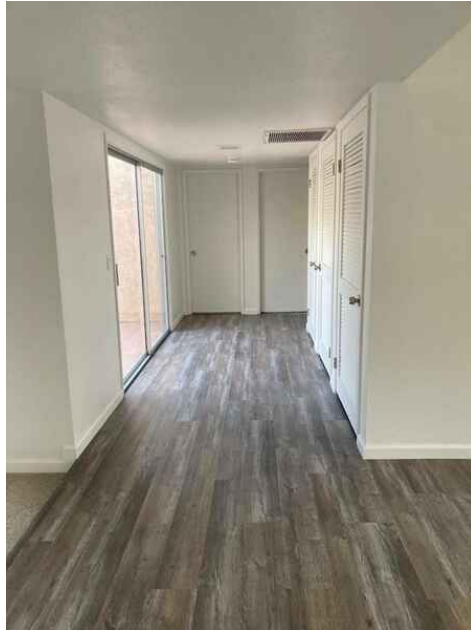
NEW VINYL PLANK FLOORING!

A professional covered the worn and dated tile floors with a new, durable and attractive vinyl plank floor.

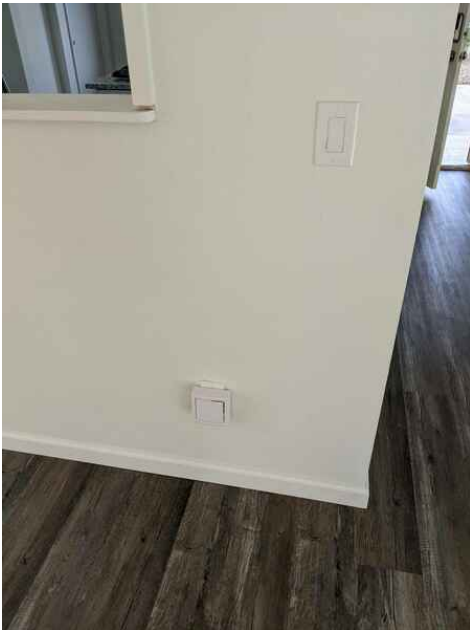
DOOR BELL NOT FUNCTIONAL

The door bell did not operate when tested. Recommend repair.

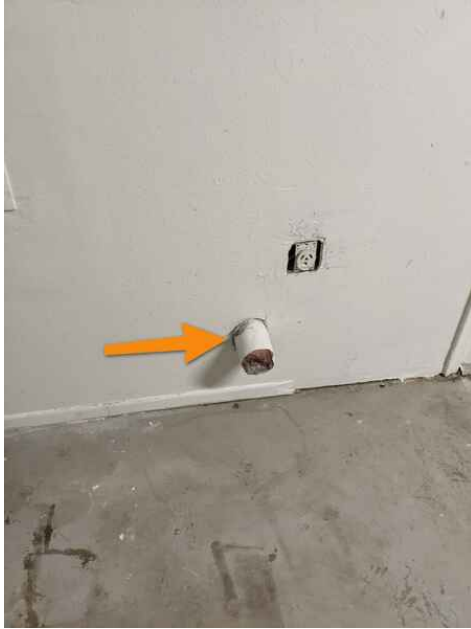
The dryer is not properly vented. Current standards require that dryer vents are exhausted to the exterior. Recommend repair.
