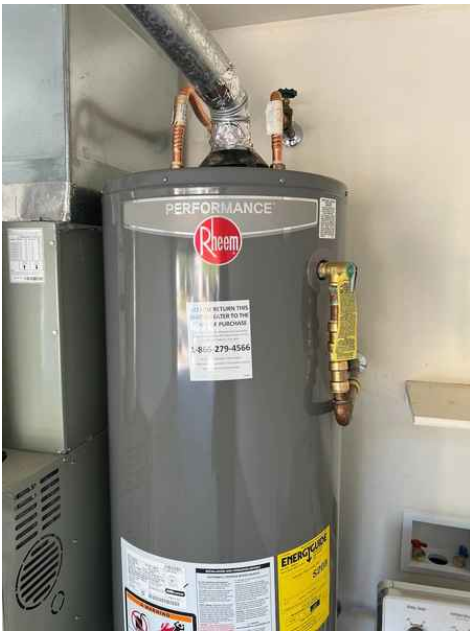
### NEW WATER HEATER!

We had a new water heater installed to replace the old unit, which had developed some leaks.
