1.1.4 Property Notes and Limitations

What Opendoor did

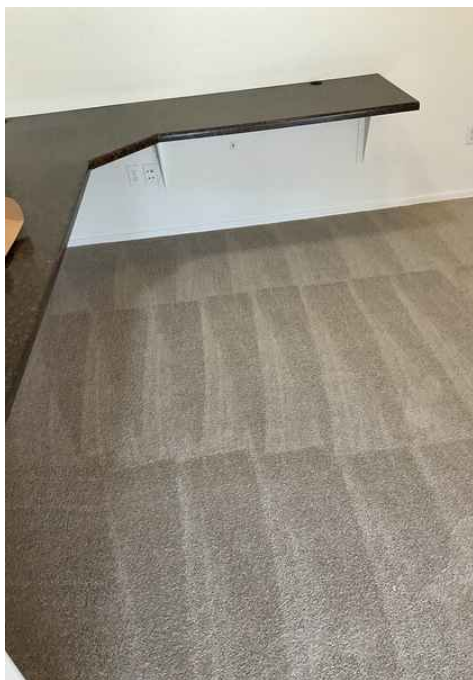
NEW CARPET!

A professional carpet demo removed all the old carpet and pad, and replaced with new, throughout the house, for a fresh feeling underfoot.

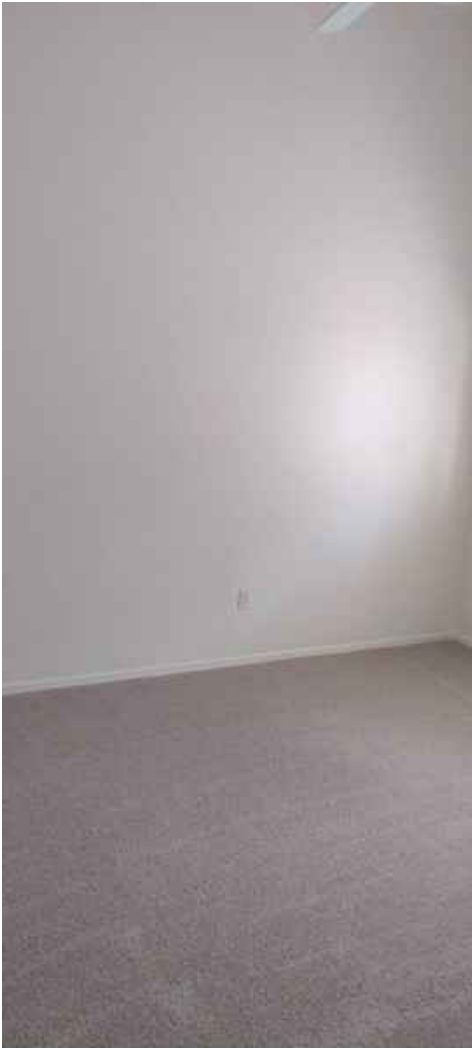
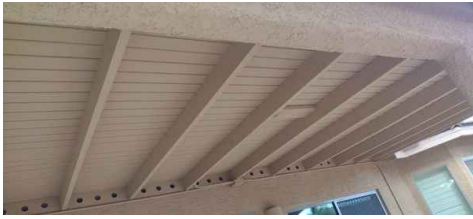
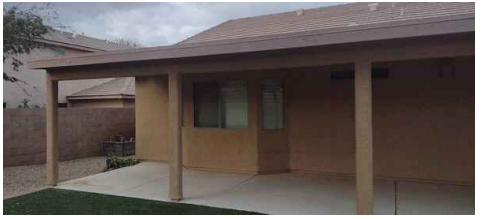
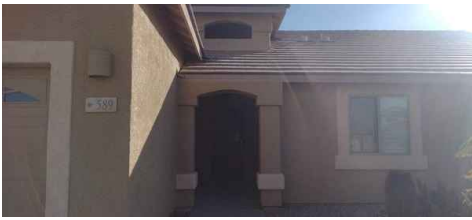
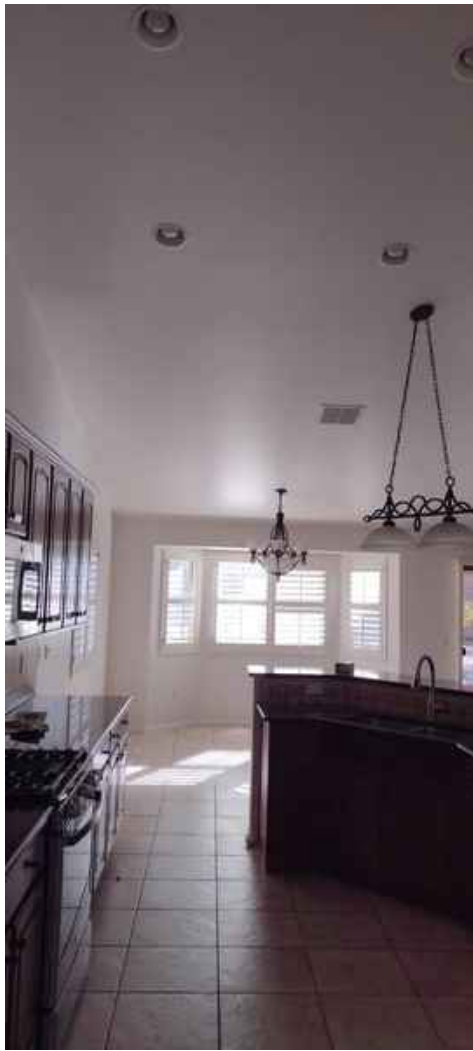
FRESH PAINT, INSIDE AND OUT!

A professional painting crew painted this home, both inside and out, for a fresh start for the next owner.
