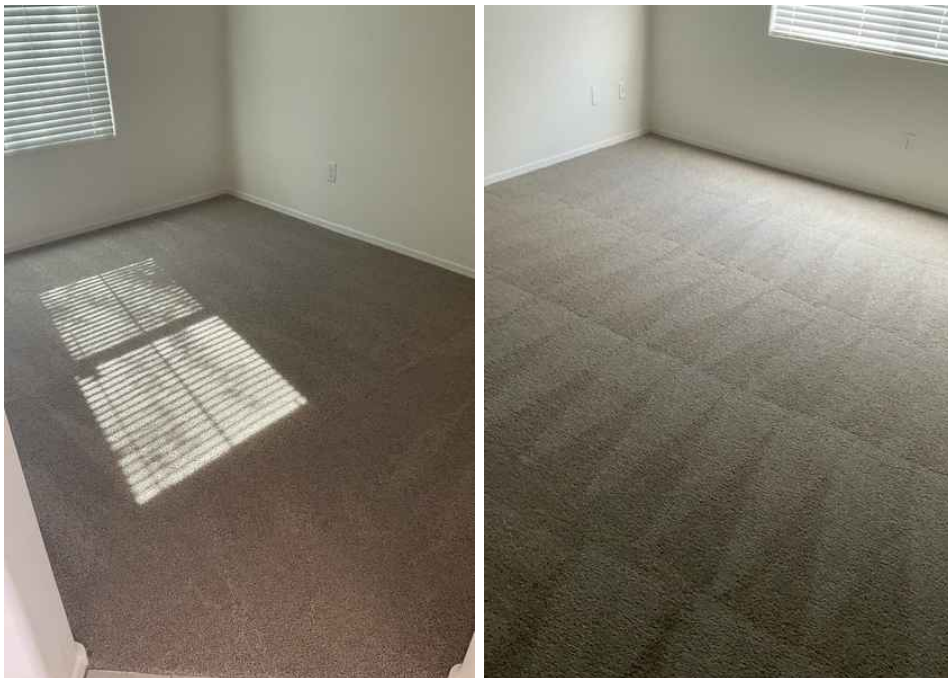
NEW CARPET!

We installed new carpet and pad throughout the house, for a fresh feel underfoot.

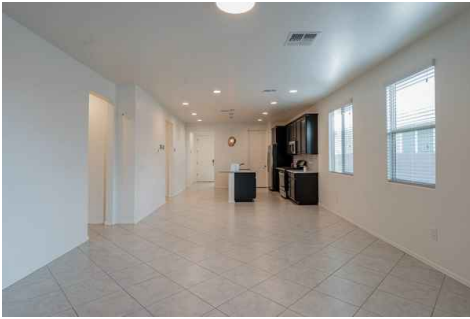
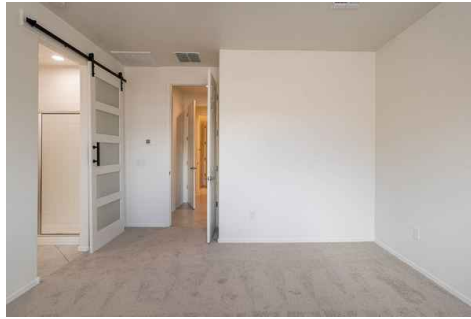
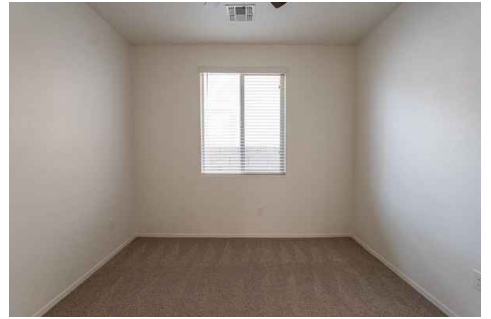
NEW PAINT!

We had the interior walls and trim painted for a fresh new look for the next owner.

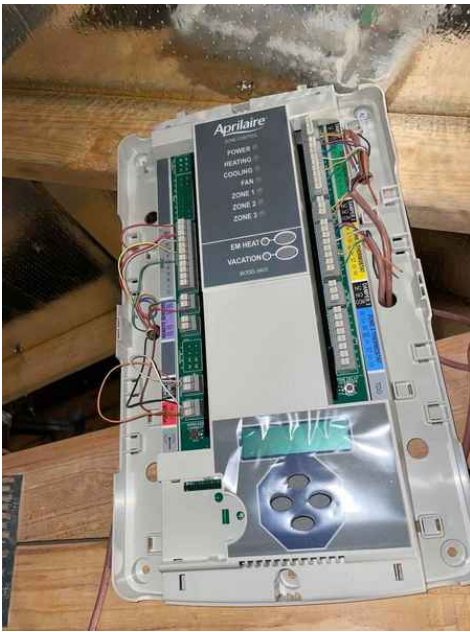
COOLING - UNIT NOT RESPONSIVE/FUNCTIONAL

The HVAC system is inoperable or the unit is not responsive to the controls. The function of all components associated with the HVAC system including the condenser, ducting, distribution of air, and function of the system cannot be verified. Recommend an HVAC specialist repair the unit and verify functional operation.

A professional replaced the control board and thermostat in order to complete a successful test of the unit.

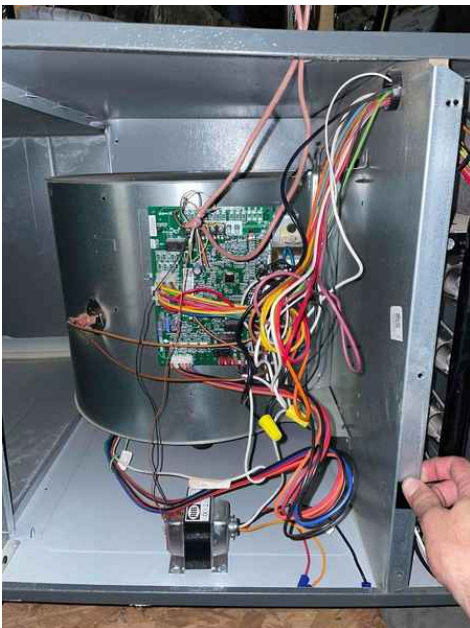
HEATING - FURNACE NOT FUNCTIONAL

The furnace is not functioning properly at the time of inspection. Recommend further evaluation and repair as needed.

A professional replaced the control board and thermostat in order to complete a successful test of the unit.

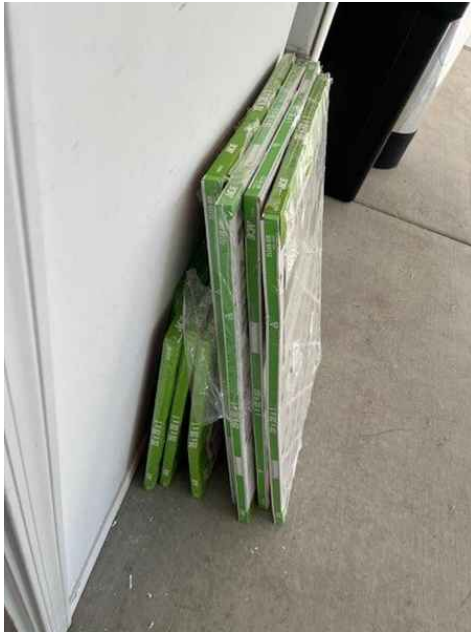
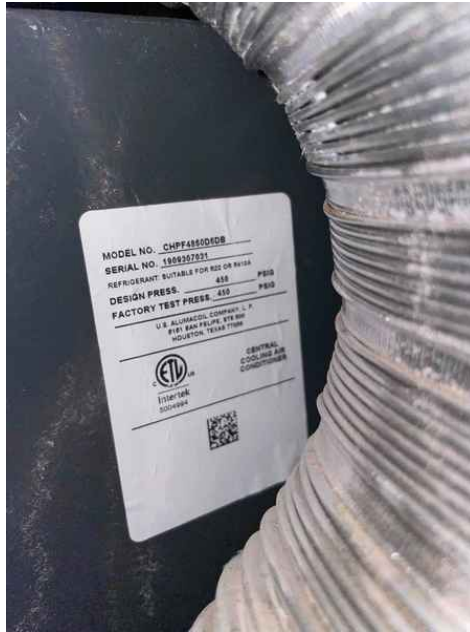
NO VISIBLE SERVICE DATE - SERVICE RECOMMENDED

The last service date is over one year ago or is unable to be determined. The unit may be operating properly from controls but there are areas which cannot be seen without specialized equipment, removing covered areas, and/or invasive examination. Recommend consulting the owner for recent service or repair records and/or have an HVAC specialist service the unit.

A professional serviced the HVAC units while onsite replacing the thermostat and control board.
