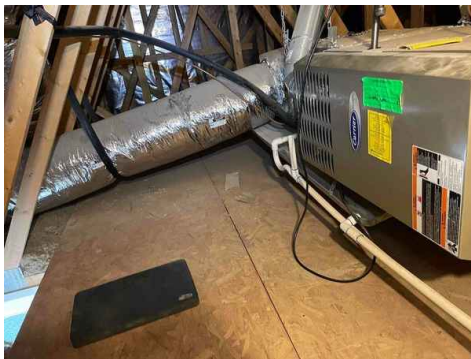
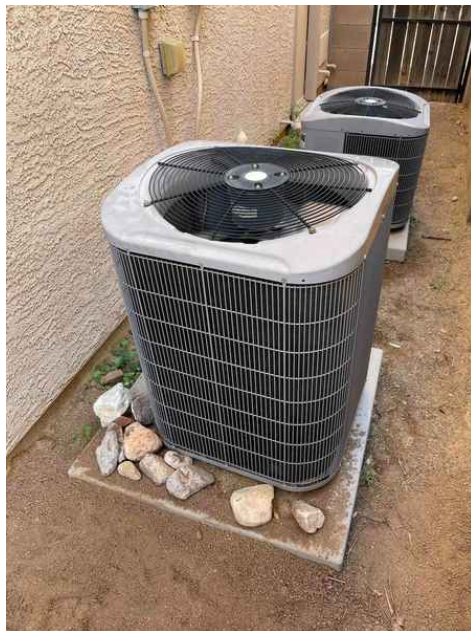
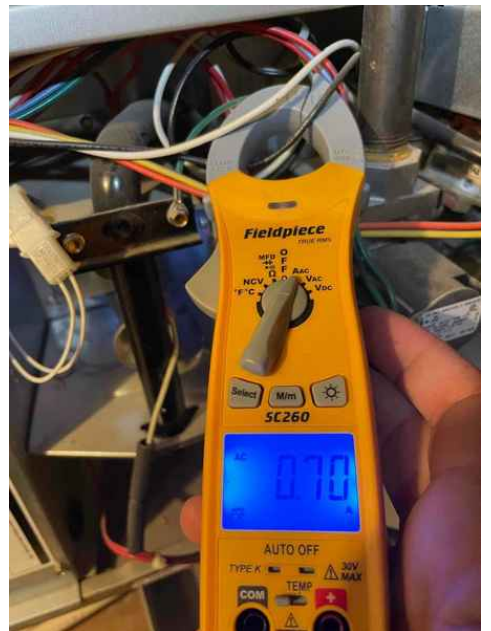
9.2.1 HVAC Inspection

NO VISIBLE SERVICE DATE - SERVICE RECOMMENDED

The last service date is over one year ago or is unable to be determined. The unit may be operating properly from controls but there are areas which cannot be seen without specialized equipment, removing covered areas, and/or invasive examination. Recommend consulting the owner for recent service or repair records and/or have an HVAC specialist service the unit.

A professional serviced the HVAC units and ensured that they were working well.

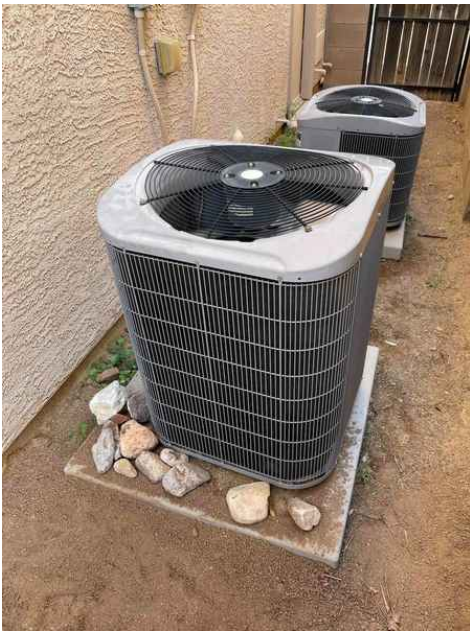
10.2.1 HVAC Inspection

NO VISIBLE SERVICE DATE - SERVICE RECOMMENDED

The last service date is over one year ago or is unable to be determined. The unit may be operating properly from controls but there are areas which cannot be seen without specialized equipment, removing covered areas, and/or invasive examination. Recommend consulting the owner for recent service or repair records and/or have an HVAC specialist service the unit.

A professional serviced the HVAC units and ensured that they were working well.
