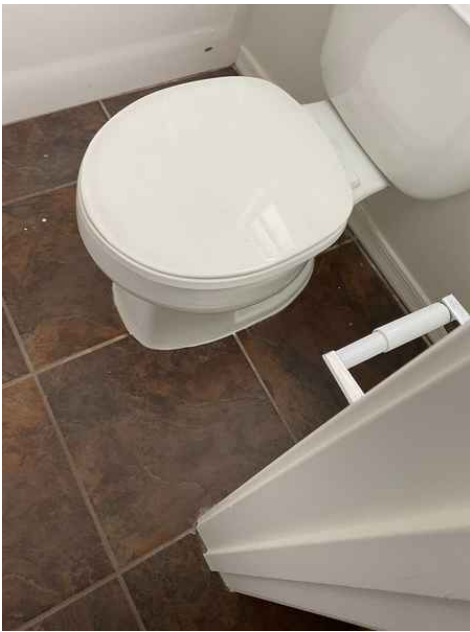
BATHROOM 3

### LOOSE TOILET AT THE BASE

The toilet is loose at the base and should be properly attached to the floor. Recommend repair.

A professional reseated this toilet with a new wax ring and made sure it's well affixed to the floor.

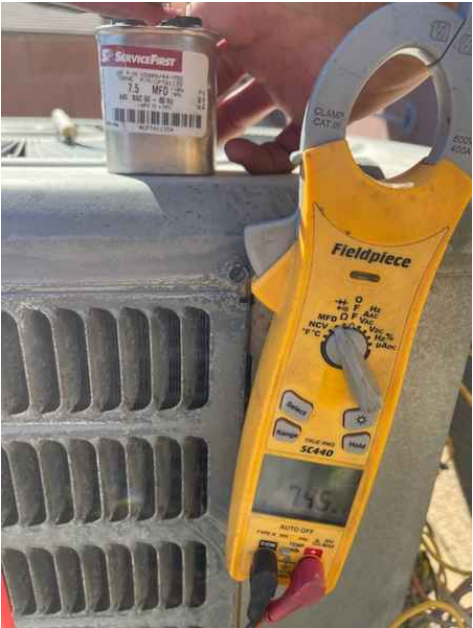
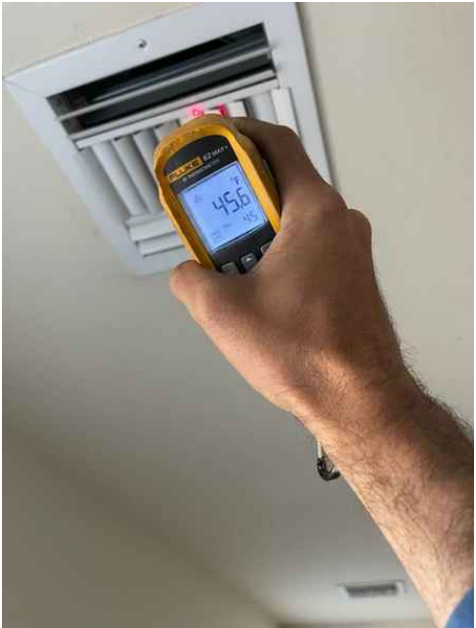
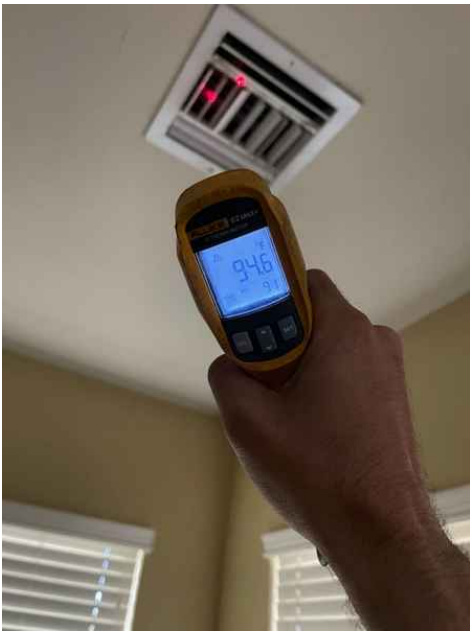
NO VISIBLE SERVICE DATE - SERVICE RECOMMENDED

The last service date is over one year ago or is unable to be determined. The unit may be operating properly from controls but there are areas which cannot be seen without specialized equipment, removing covered areas, and/or invasive examination. Recommend consulting the owner for recent service or repair records and/or have an HVAC specialist service the unit.

A professional HVAC company fully serviced this unit and made sure it is operating properly and adequately cooling and heating this home.
