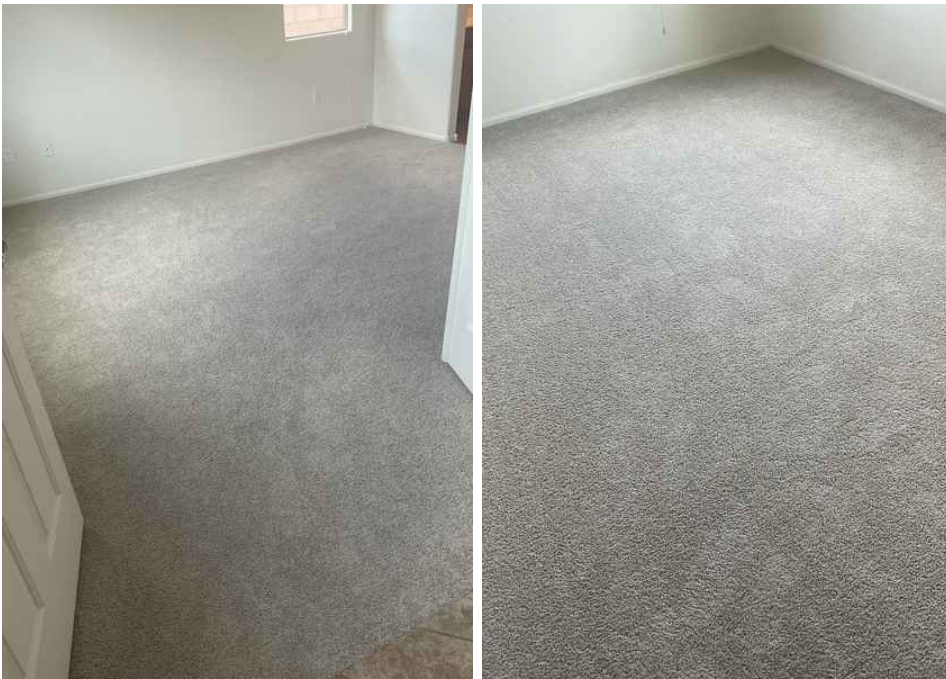
We installed all new carpet and pad throughout the house, for a delightful new feeling underfoot. We hope the next owner enjoys them.

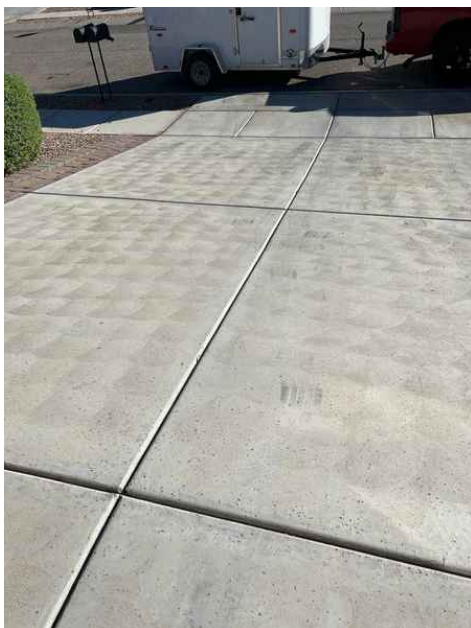
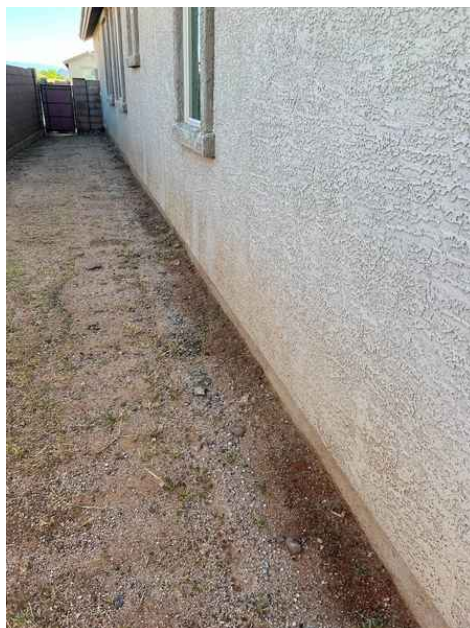
We pressure washed the exterior of the home, driveway, and garage floor to remove dirt and dust.

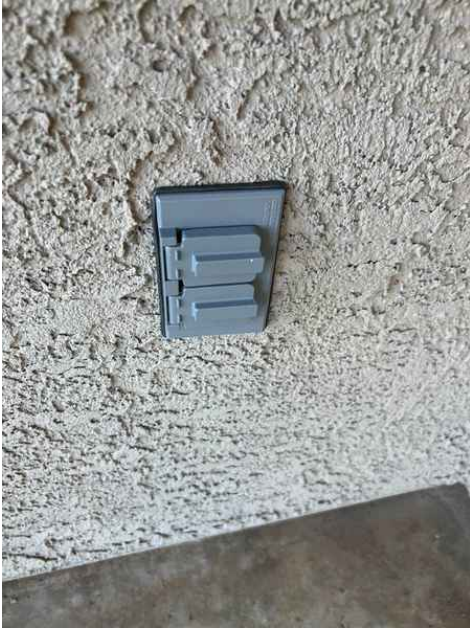
We replaced two broken exterior outlet covers for safety.

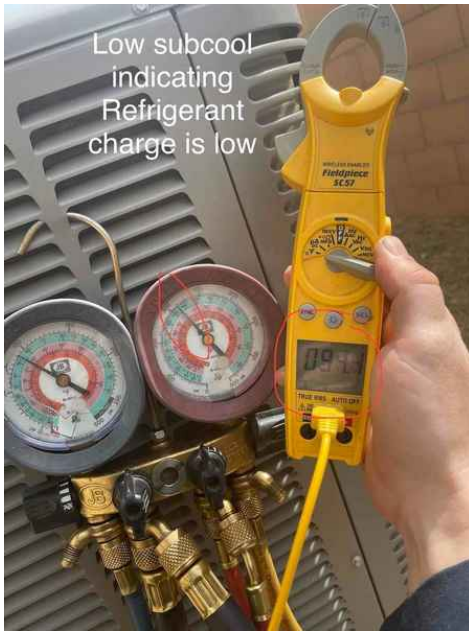
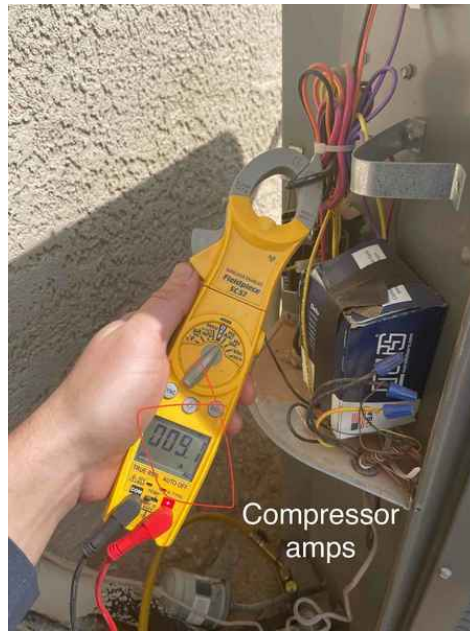
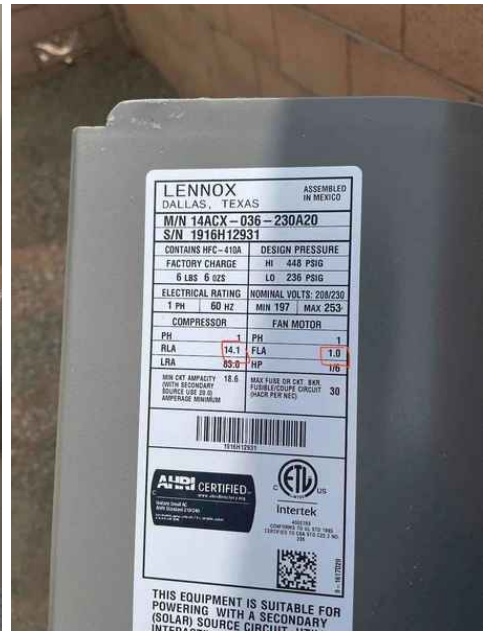
The last service date is over one year ago or is unable to be determined. The unit may be operating properly from controls but there are areas which cannot be seen without specialized equipment, removing covered areas, and/or invasive examination. Recommend consulting the owner for recent service or repair records and/or have an HVAC specialist service the unit.

9 amps while running (not on high)

Amp ranges from on to running on high

We had a qualified HVAC company come out and inspect and service the AC and heat units on this home.
