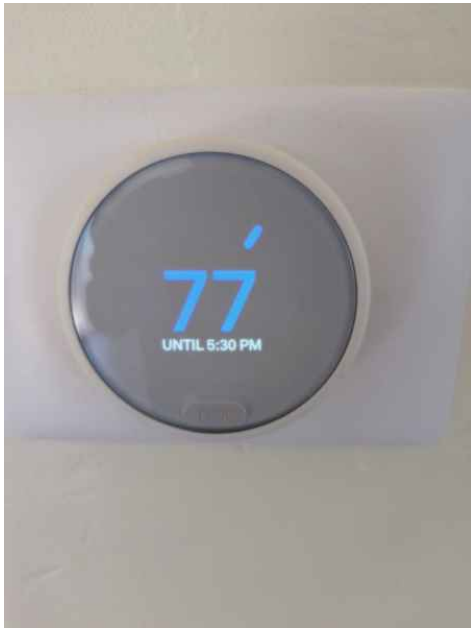
9.2.1 HVAC Inspection

NO VISIBLE SERVICE DATE - SERVICE RECOMMENDED

The last service date is over one year ago or is unable to be determined. The unit may be operating properly from controls but there are areas which cannot be seen without specialized equipment, removing covered areas, and/or invasive examination. Recommend consulting the owner for recent service or repair records and/or have an HVAC specialist service the unit.

The inspector noted that this home's AC and heater were operating properly and within specified ranges. However we do recommend that the next owner set up an annual servicing with a reputable HVAC company in the area to keep things running well.
