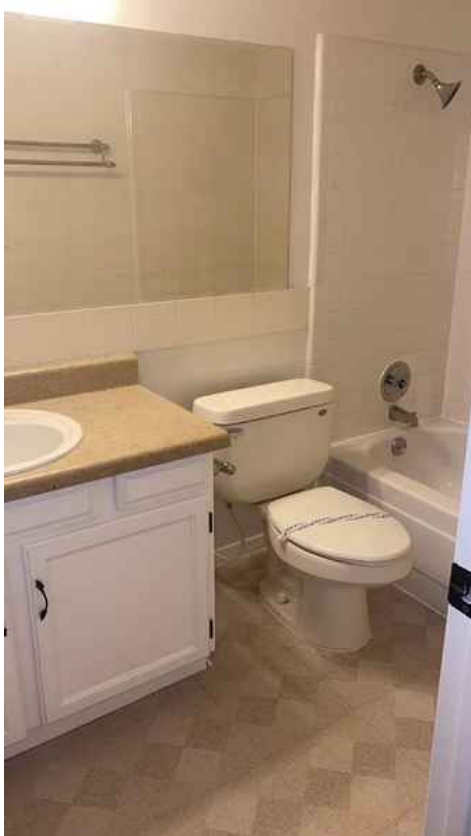
6.6.2 Toilets

TOILET RUNNING

PRIMARY BATHROOM

The toilet continues to run after flushing. Recommend repair or replace the interior tank components.

A professional installed a new flush kit in this toilet tank.

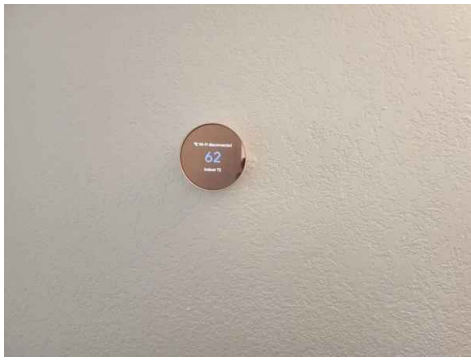
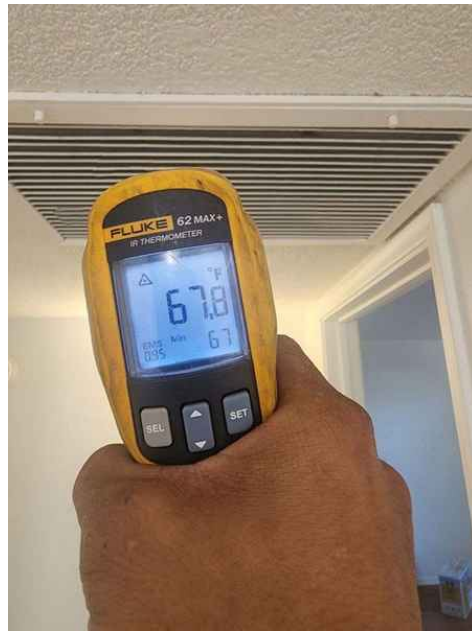
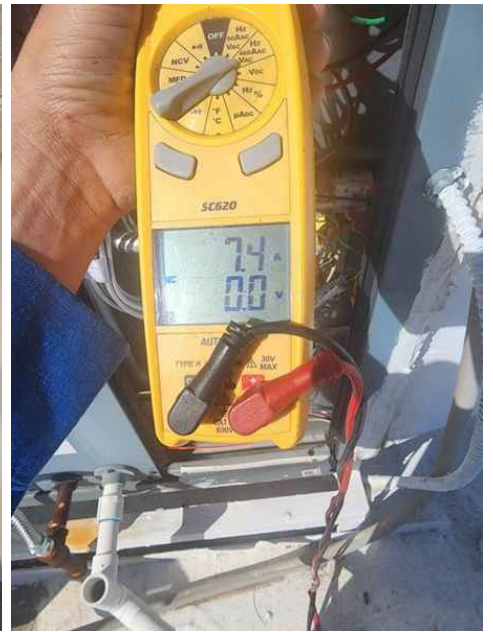
8.2.1 HVAC Inspection

NO VISIBLE SERVICE DATE - SERVICE RECOMMENDED

The last service date is over one year ago or is unable to be determined. The unit may be operating properly from controls but there are areas which cannot be seen without specialized equipment, removing covered areas, and/or invasive examination. Recommend consulting the owner for recent service or repair records and/or have an HVAC specialist service the unit.

A professional serviced this HVAC system to ensure that it is ready for use by the next owner.
