1.1.1 Property Notes and Limitations

**SIGNS OF TERMITE DAMAGE/PRESENCE**

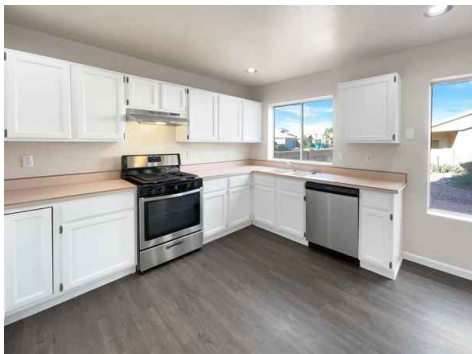
**NEW KITCHEN RANGE, HOOD, AND DISHERWASHER!**

We had professional install a new dishwasher, range, and hood in this home in an attractive stainless steel finish so the next owner can get cooking right when they move in.

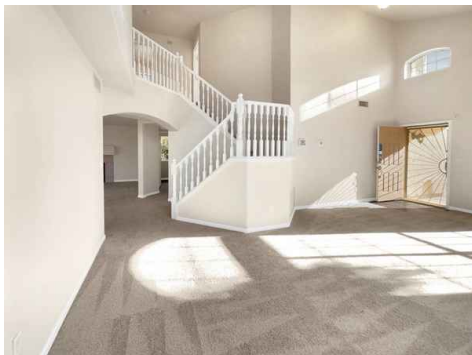
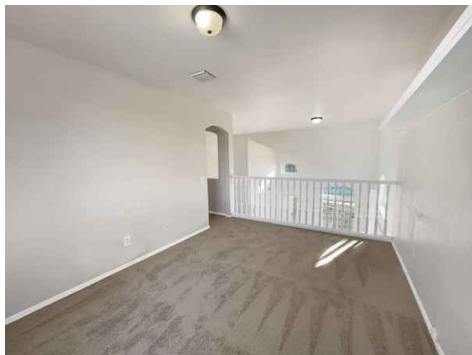
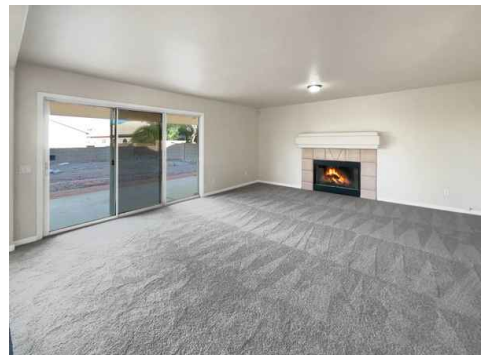
### NEW CARPET!

We had new carpet and pad installed throughout the home for a fresh feeling underfoot.

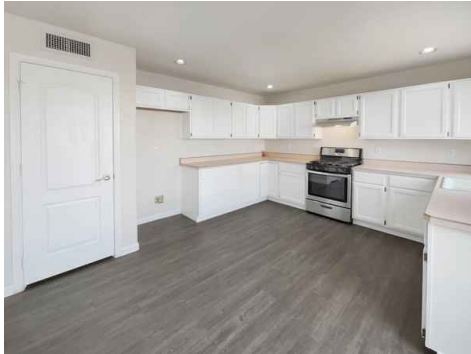
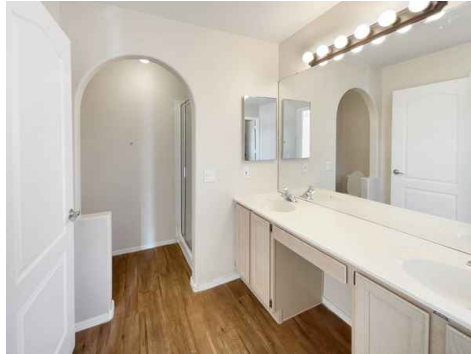
## NEW FLOORING IN KITCHEN AND BATH!

We had attractive new vinyl plank flooring installed in the kitchen as well as one of the bathrooms for a stylish and water resistant fresh start.

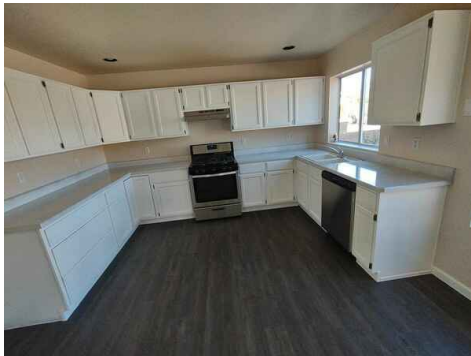
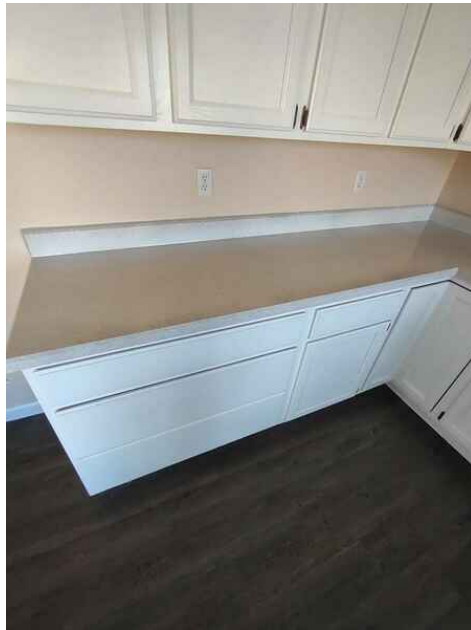
## REFINISHED COUNTERTOPS!

We had an attractive and durable epoxy coating applied to the existing countertops to brighten this space and make for a better work surface for the next owner.

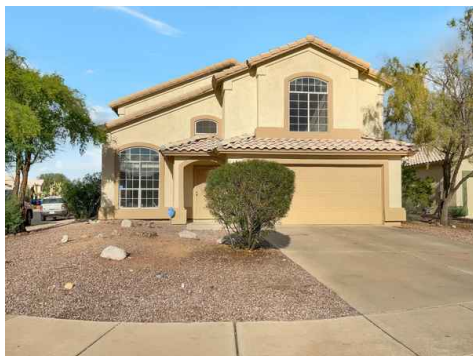
This home had a tired exterior that has been refreshed in stylish new colors making it a standout in the neighborhood.

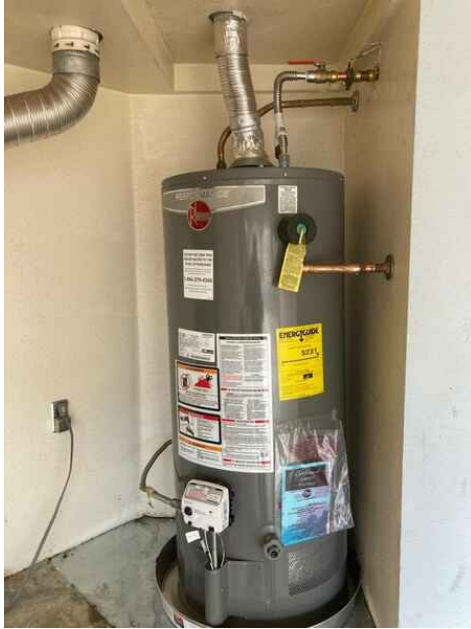
We installed a new water heater in this home for years of reliable service for the new owner.
