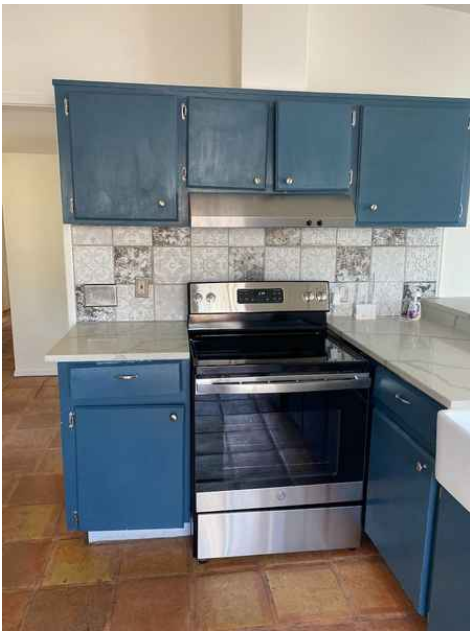
Hood and stove replacement
NEW STOVE AND HOOD

A new stove and range hood have been installed in this house to provide years of service, and great meals.

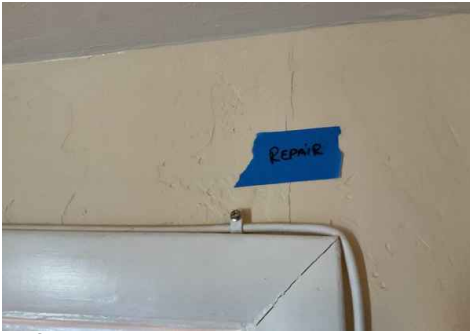
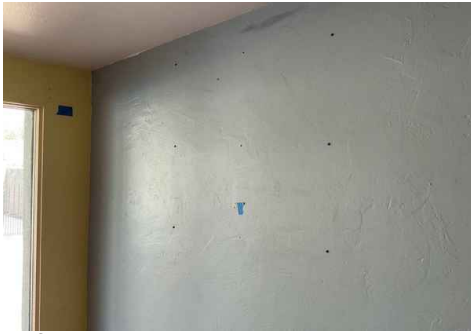
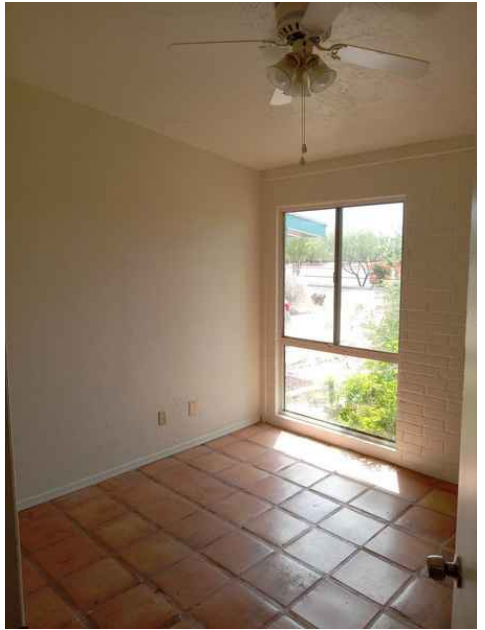
DRYWALL REPAIR

A number of drywall repairs were made prior to painting the home so that all surfaces have a uniform appearance.

Before

After

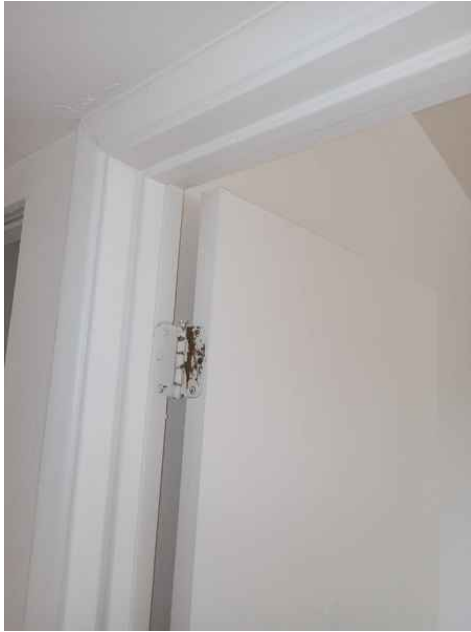
BEDROOM DOOR REPAIR

We noticed a delaminating door to the bedroom, so the construction team put it back together so it looks, and operates, as intended.

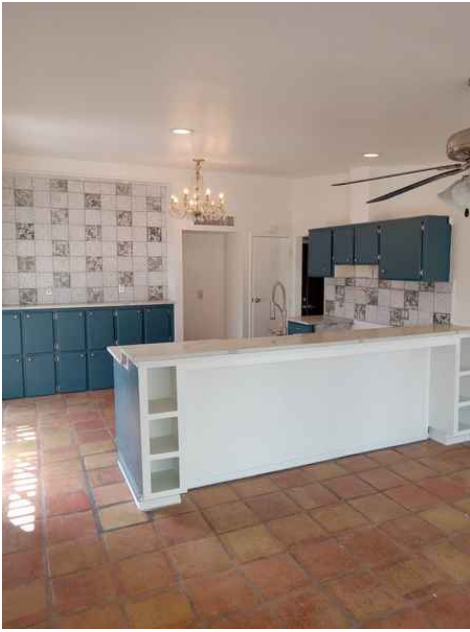
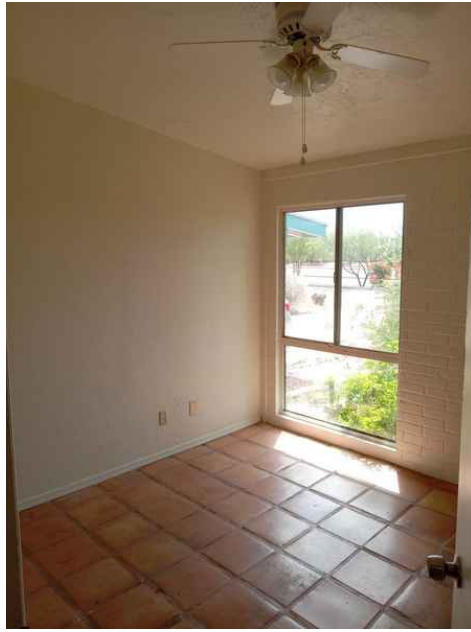
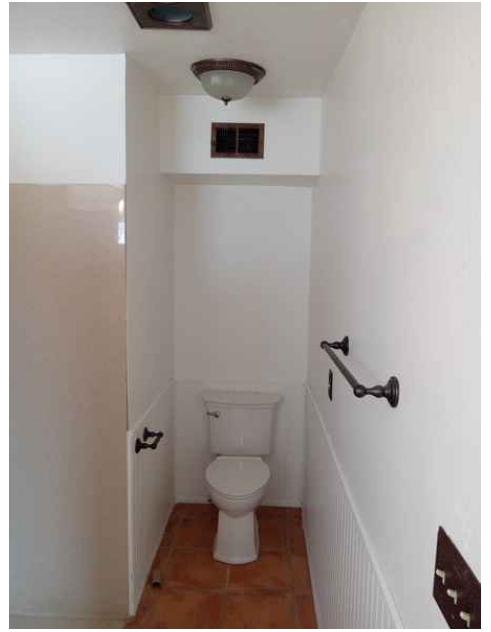
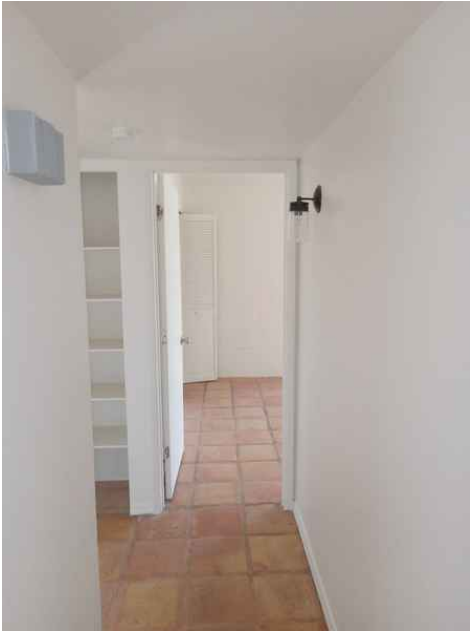
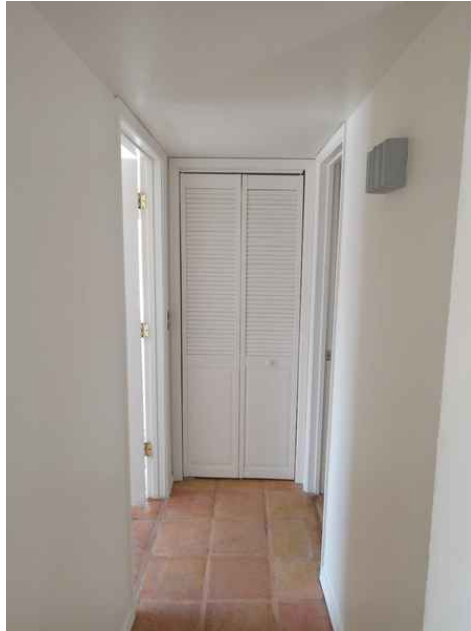
INTERIOR REPAINT

Our construction team performed a full interior repaint to ensure the home is bright and fresh for its new owners.

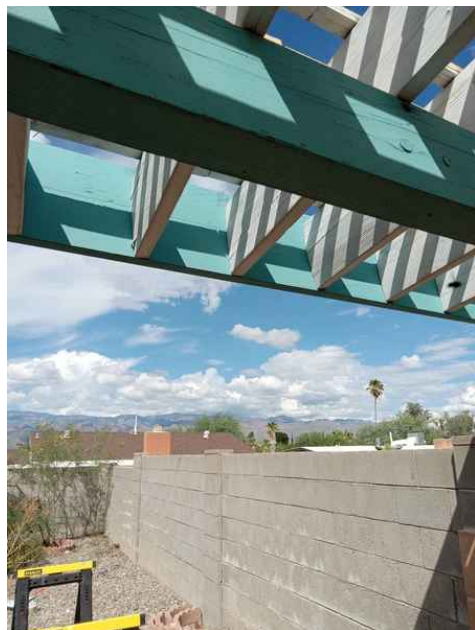
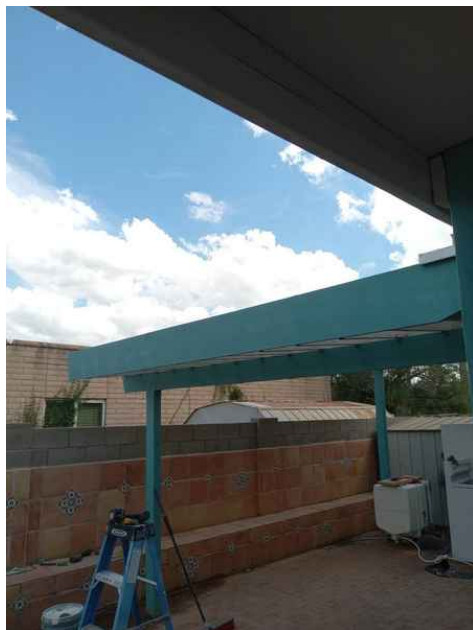
PERGOLA REPAIR

We observed some damage to the pergola, which was pulling away and badly in need of paint. Our construction crew refastened the fascia where needed and gave it a matching coat of paint.

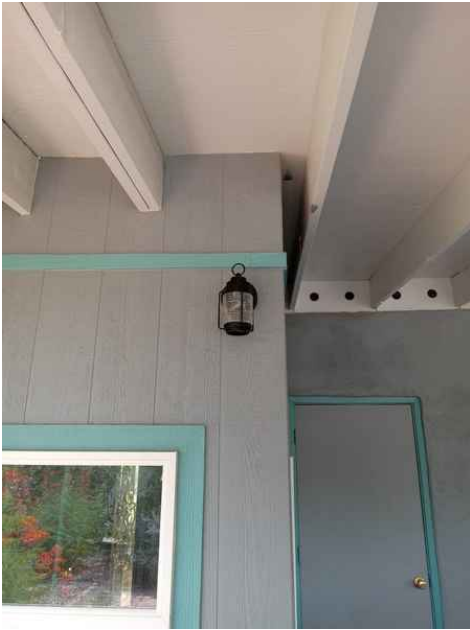
NEW FRONT PORCH LIGHT

The construction team noticed that there was no front porch light present. That can be a safety issue, and is certainly a nuisance. A new light has now been installed.

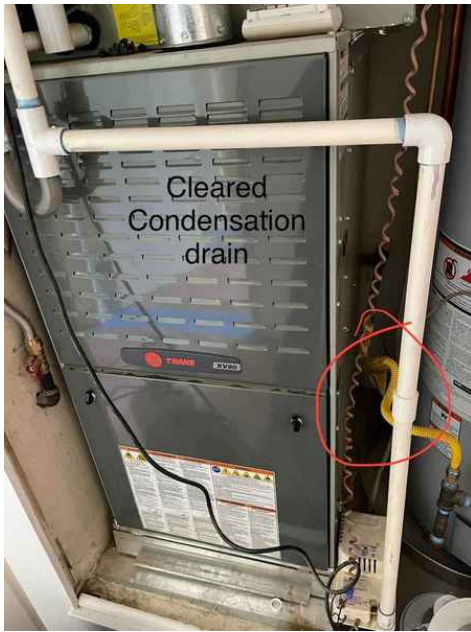
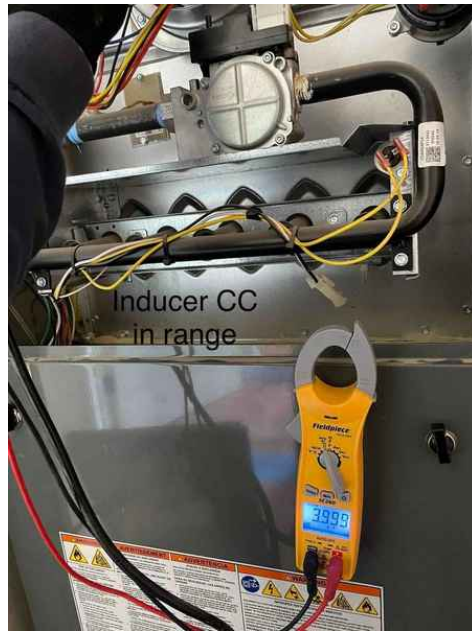
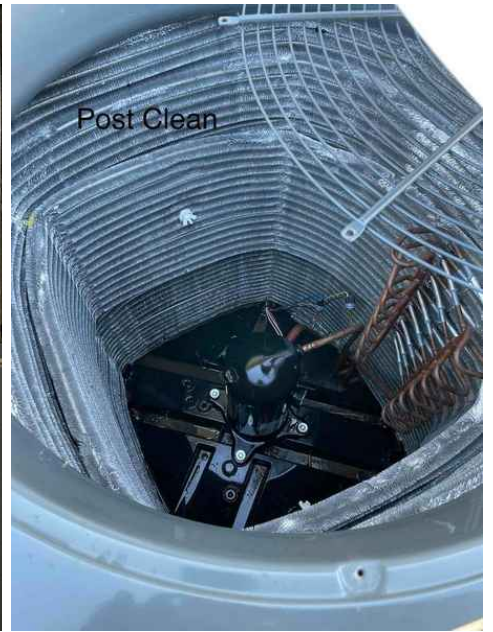
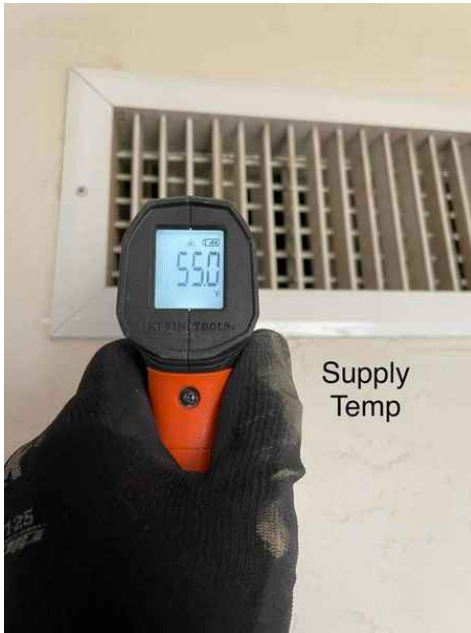
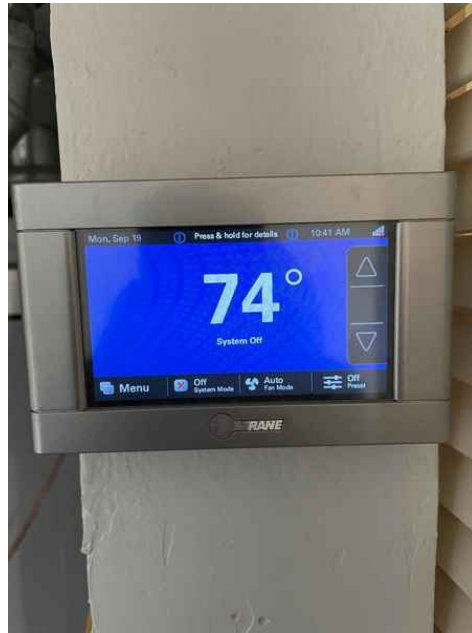
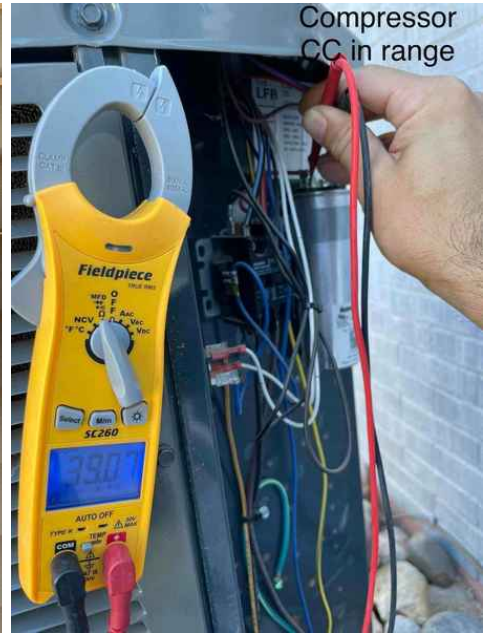
NO VISIBLE SERVICE DATE - SERVICE RECOMMENDED

The last service date is over one year ago or is unable to be determined. The unit may be operating properly from controls but there are areas which cannot be seen without specialized equipment, removing covered areas, and/or invasive examination. Recommend consulting the owner for recent service or repair records and/or have an HVAC specialist service the unit.

A professional service was performed on the entire HVAC system, and it has been given a clean bill of health. In addition, a new thermostat has been installed.
