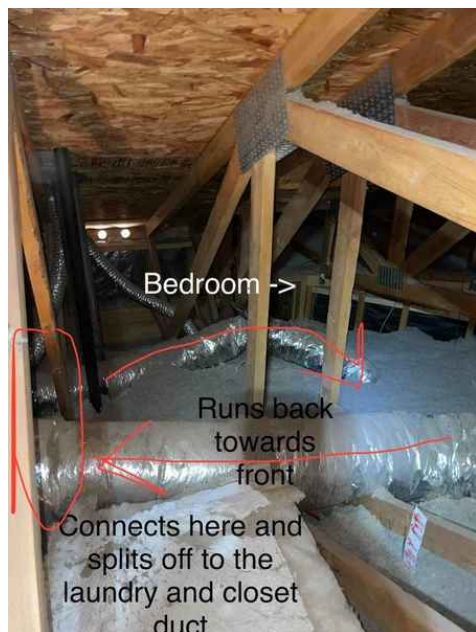
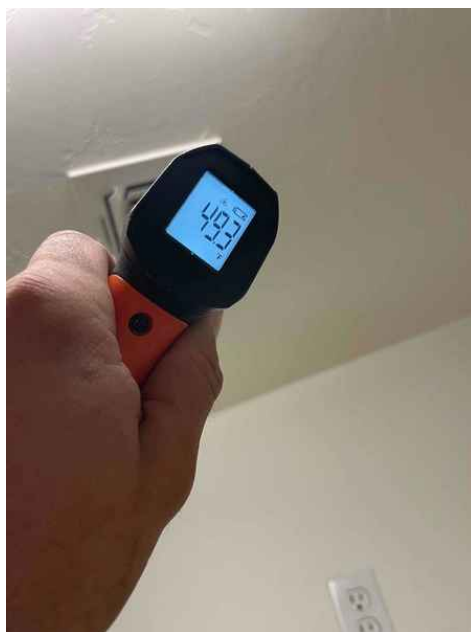
### 9.2.1 HVAC Inspection

## NO VISIBLE SERVICE DATE - SERVICE RECOMMENDED

The last service date is over one year ago or is unable to be determined. The unit may be operating properly from controls but there are areas which cannot be seen without specialized equipment, removing covered areas, and/or invasive examination. Recommend consulting the owner for recent service or repair records and/or have an HVAC specialist service the unit.

A professional serviced this HVAC system and replaced the condenser motor as well as noted that the unit is operating properly and all readings are within manufacture specs at this time. The unit is draining properly and shows no signs of leaks. Installing the new condenser motor helped with temperatures in laundry room and master bedroom closet, however, the way the systems ducts are designed, you will have less air flow in those particular areas.

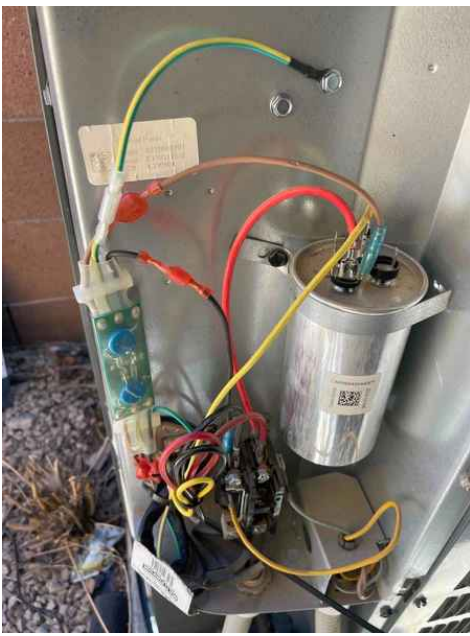
Model: GSX140371 Rev#: KC  
Model Desc.: 14 SEER AC, 3 TON  
Mfg Date: 3/22/2017

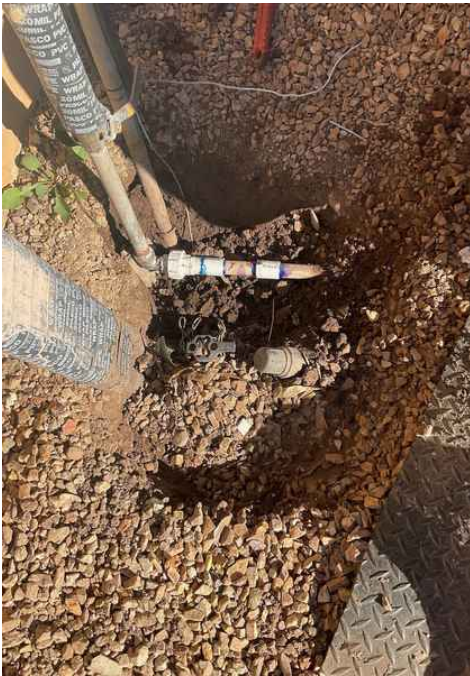
#### 13.1.2 General

### SYSTEM NOT FUNCTIONAL

The sprinkler system is inoperable or no longer functional at the time of inspection. Recommend further evaluation of the system by a landscaper and repair as needed.

A professional repaired the leak in the system and confirmed that it operated as it should.
