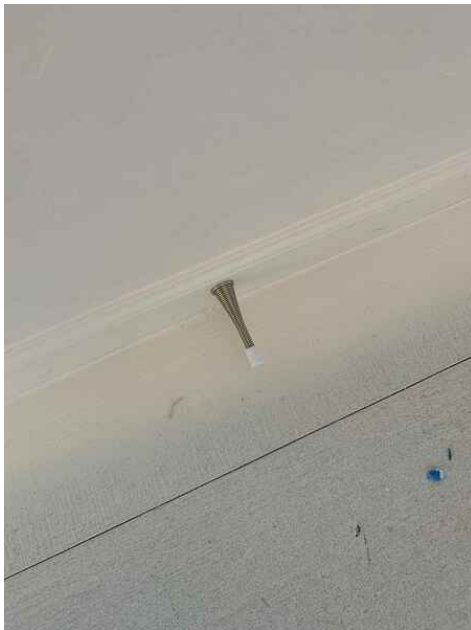
Replace or add missing door stoppers to prevent damage to the drywall.

A professional installed door stops throughout the home.

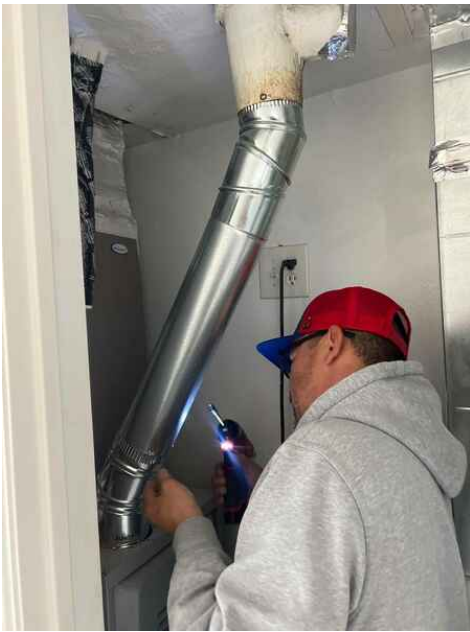
The last service date is over one year ago or is unable to be determined. The unit may be operating properly from controls but there are areas which cannot be seen without specialized equipment, removing covered areas, and/or invasive examination. Recommend consulting the owner for recent service or repair records and/or have an HVAC specialist service the unit.

A professional performed a service repair on the furnace.
