2.2.2 Dishwasher

What Opendoor did

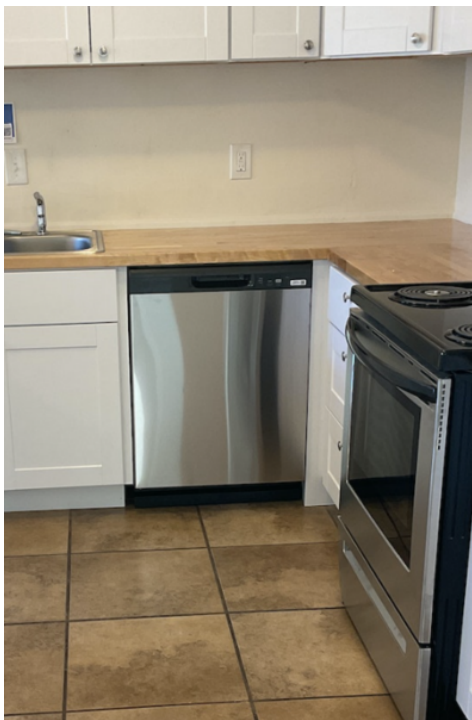
DISHWASHER NOT TESTED - WATER SERVICE OFF

The water service is off at time of the inspection. Unable to determine the condition of the system and/or the function of plumbing fixtures. The unit has not been tested.

A professional installed a new dishwasher in this house.

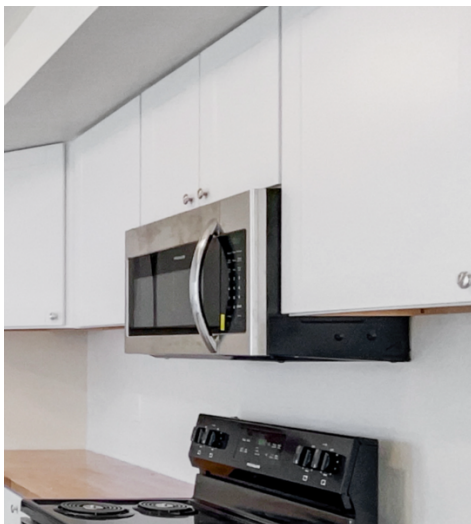
2.5.1 Microwave

MICROWAVE IS INOPERABLE

The microwave is inoperable at the time of inspection or not functioning properly. Recommend repair.

A professional installed a brand new microwave in this home.

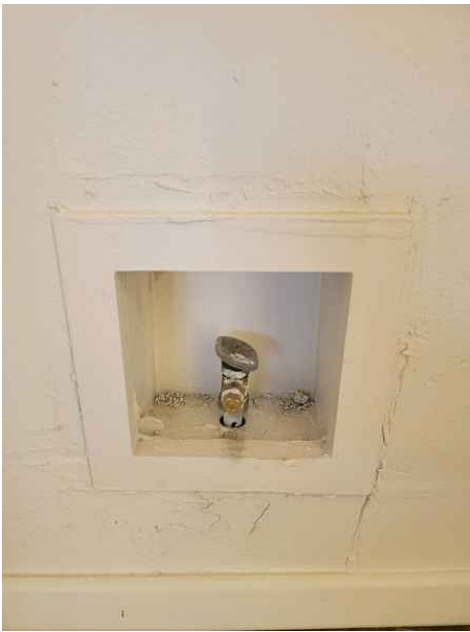
The plumbing features of the refrigerator are inoperable or not responsive when tested (water shut off to house). Recommend repair.

A professional removed the broken refrigerator from this home and checked the water valve and it is ready to be hooked up to the next owner's fridge of choice when they purchase it.

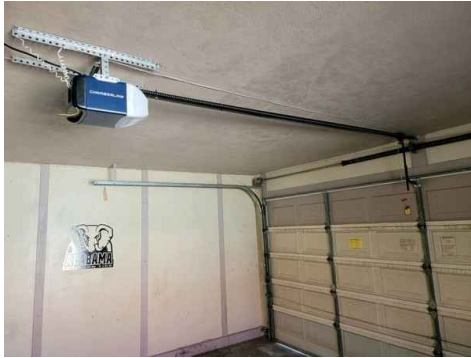
The garage door is not tested at the time of inspection due to the current condition. Unable to test the door, functionality of the motor, and safety mechanism. Recommend remedying the condition and repair as directed.

A professional installed a new motor with new optical sensors, new tracks, and replaced two panels on the door that had been damaged. The entire system was then tuned and tested and is operating well.

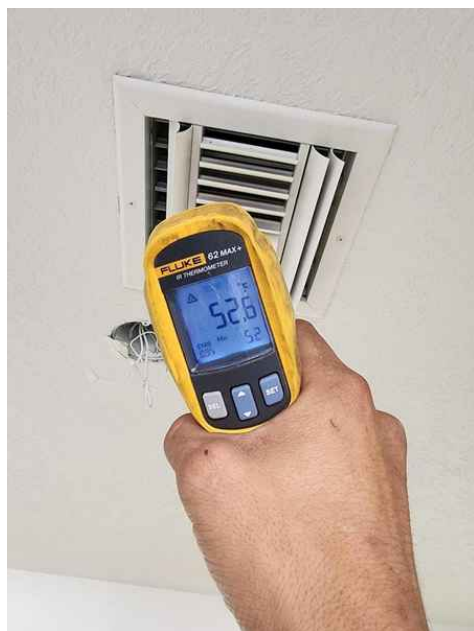
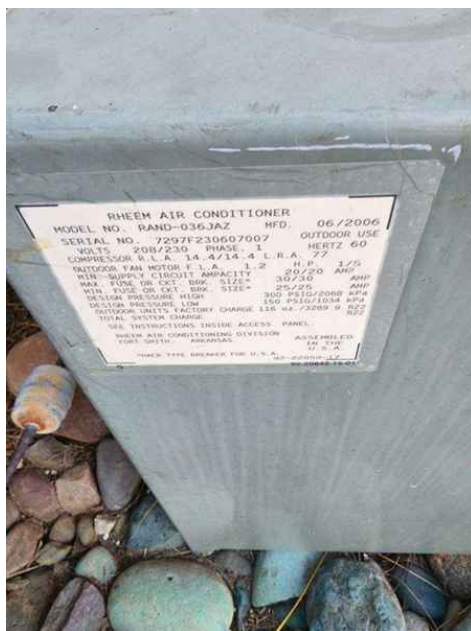
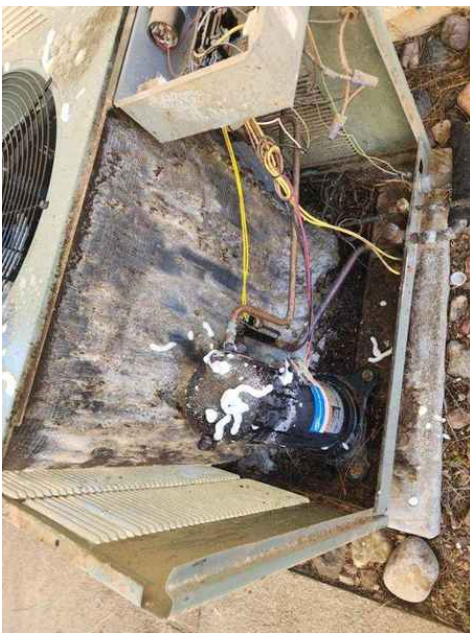
NO VISIBLE SERVICE DATE - SERVICE RECOMMENDED

The last service date is over one year ago or is unable to be determined. The unit may be operating properly from controls but there are areas which cannot be seen without specialized equipment, removing covered areas, and/or invasive examination. Recommend consulting the owner for recent service or repair records and/or have an HVAC specialist service the unit.

In addition to repairing the furnace, an HVAC professional serviced the whole system, including all the air conditioner components.
